Investigation of materials and damage sources of local masonry structures in Turkey

B. Zengin¹, M. Bulduk², E. Aydın², E. Koşar² & A. Z. Altay²

¹Vocational School, İstanbul Gelisim University, İstanbul, Turkey

²Department of Civil Engineering, Yıldız Technical University, Turkey

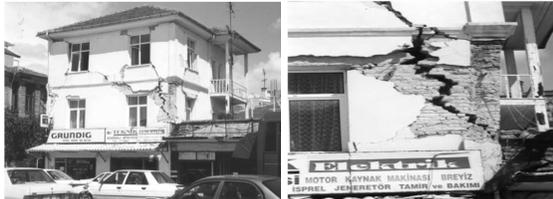
Due to earthquake loads, damage occurs in some regions of masonry structures. Because of stress concentrations, especially on the sides of doors and windows, masonry structures achieve their failure mechanisms with diagonal cracks. Turkish Seismic Code mandates that openings must be at least 1.5 m away from the corners of the structure. In Figure 4 below, this type of damage

can be observed in a structure that was affected by the Kocaeli earthquake in 1999.

In masonry walls that work perpendicular to the earthquake direction, vertical cracks are observed near the corners. In Figure 4 above, these types of cracks can also be seen. Furthermore, it can be said that the gable walls that are used in the attic are one of the foremost targets of earthquake damage [18].

Figure 4: Typical diagonal cracks in masonry structures [17].

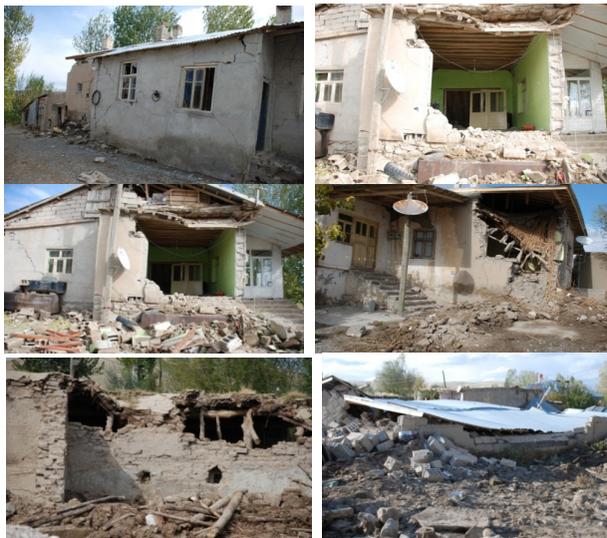
In-plane loaded diaphragms cause out-of-plane effects on the walls in their vicinity. Damages that occur in diaphragms do not greatly affect vertical structural load capacity. Flexible slab diaphragms act as high beams running between walls. In-plane rotations at the edge of diaphragms cause damage at the corners of the walls. If a good load transfer does not exist between the diaphragm and the walls, the longitudinal bending that occurs especially in narrow and tall buildings will push the corner of the diaphragm wall since it cannot be transferred to the shorter side of the wall [20]. In Figure 5 below, examples of damage in masonry structures are presented.

Figure 5: Damage examples in masonry structures.
