# THE FRACTOGRAPHIC INVESTIGATION OF AN AEROENGINE ACCESSORY GEARBOX QUILL SHAFT

Tamer Saraçyakupoğlu • ORCID 0000-0001-5338-726X

## ABSTRACT

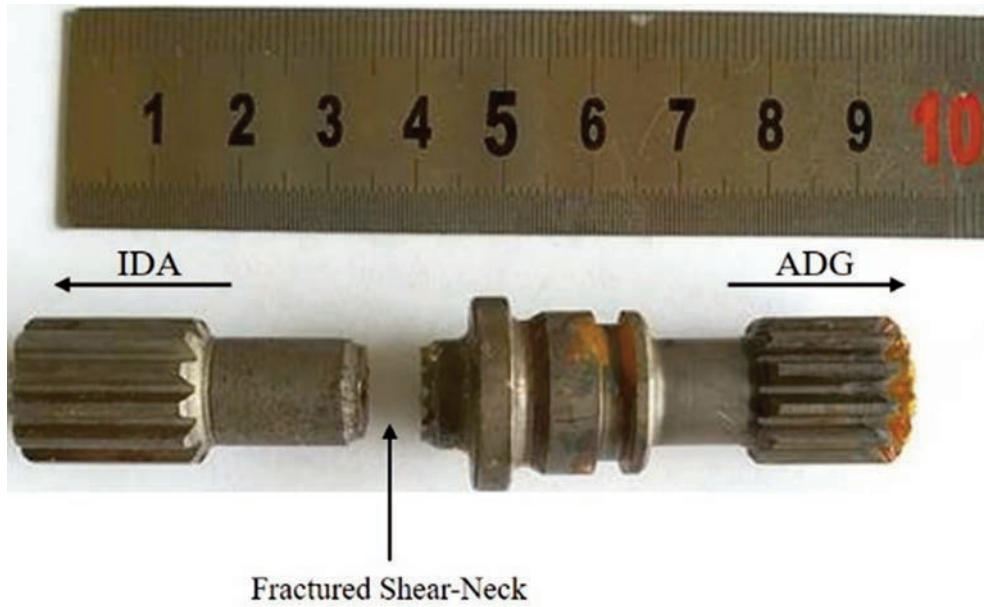
Respectively, ADG and IDA were controlled visually. Firstly, ADG was disassembled and IDA was opened for further study. Examination revealed that lateral fracture separated the shaft from the shear-neck section. As it was mentioned earlier, the purpose of the shear-neck is being fractured when the torsional loading exceeds the designed limits of the ADG's coupling shafts. As it is shown in Figure 5, the quill shaft is fractured from the shear-neck section.

Fig. 5. The Fractured Shear-Neck of the Shaft.

It was observed that on the right side (ADG side) of the shaft, there are corrosion concentration sites that might be occurred because of misalignment. Moreover, pitting corrosion was observed on the grooved area of the shaft. The oscillatory cyclic load between shafts can cause fretting corrosion and hence result in wear of surfaces. The fretting wear was considered as originated from bending forces that lead to crack nucleation and hence the corrosion propagation through the micro-cracks [8]. In other words, irregular and excessive contact is a literal conclusion of the shaft misalignment during the assembly of the ADG and IDA. However, tilt behavior can cause an angular misalignment between units (In this case ADG and IDA) accelerating the fretting and abrasive wear [9]. The fretting increases as the lubricant deteriorate and in the presence of surface irregularities such as dents or scratches [10].

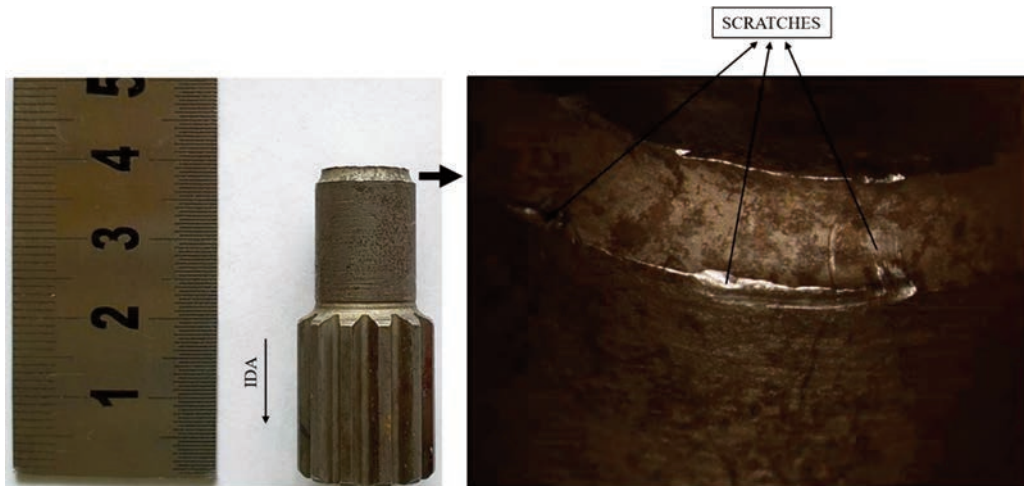
The Field Emission Scanning Electron Microscope (SEM), Fluorescent-Penetration Inspection (FPI), Binocular Stereo Microscope (BSM), Image Analyzer (IA), and Rockwell Hardness Measurement device (RHM) methodologies were used for the fractographic analysis of the fractured shaft. It was determined that there were damages such as fretting and scratching in the fracture zone, due to the impact intersecting with the fracture cross-sectional surface as it is shown in Figure 6.

Fig. 6. The Fretting and Scratching in the Fracture Zone of Non-Corroded Side of the Shaft.

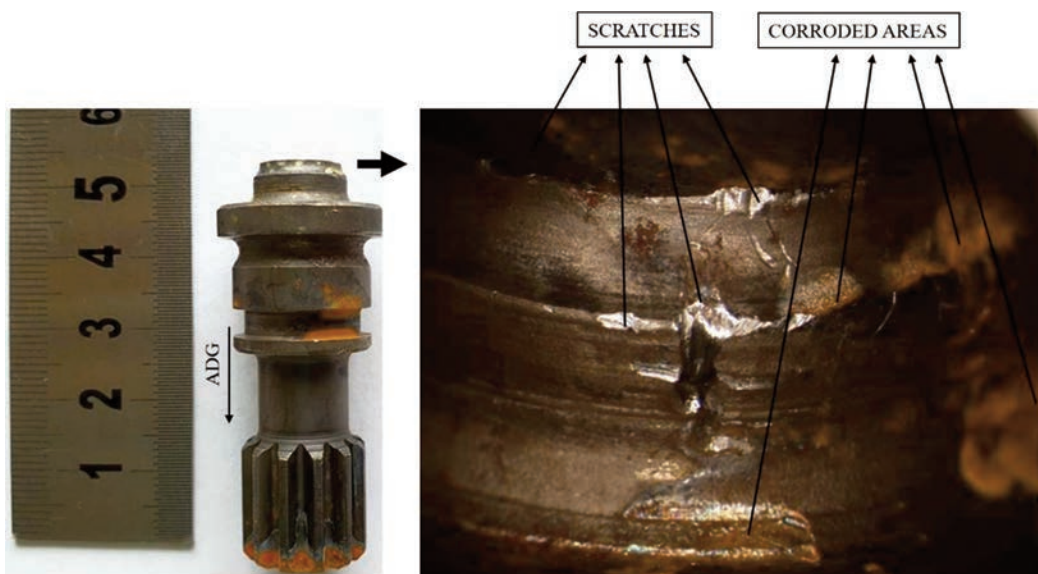
Micro-cracks and scratches are clearly seen on the sheared surface of the shaft as a result of BSM and IA based investigation. Also, the scratches and corrosion concentration areas are shown in Figure 7.

Fig. 7. The Fretting and Scratching in the Fracture Zone of Corroded Side of the Shaft

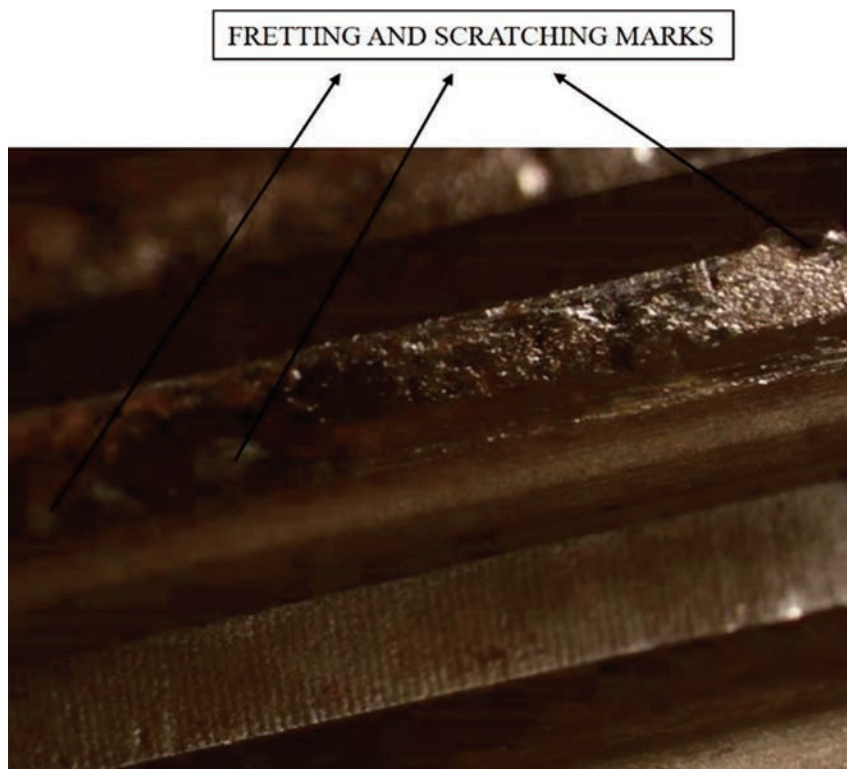
Fig. 8. The Fretting and Scratching Marks.

Due to irregular loads originated from misalignment, the shaft is predominantly subjected to torsional overloads. This overloading led the RPM decrease below 10,800 as it was regulated to revolve between 10,800 to 12,600. Consequently fretting was promoted with the empowering effect of misuse of lubricating. The fretting and scratches marks are shown in Figure 8.

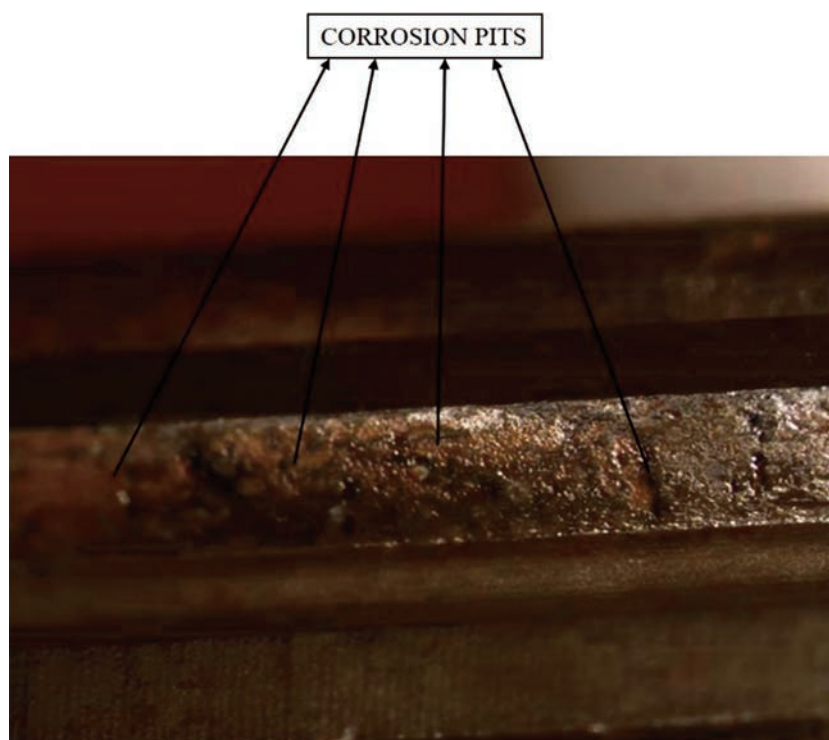
Fig. 9. The Corrosion Pits Formed in the Fritting Section.

As it was mentioned, the corrosion nucleation is initiated by the misalignment. The fretting wear originated corrosion pits are shown in Figure 9.

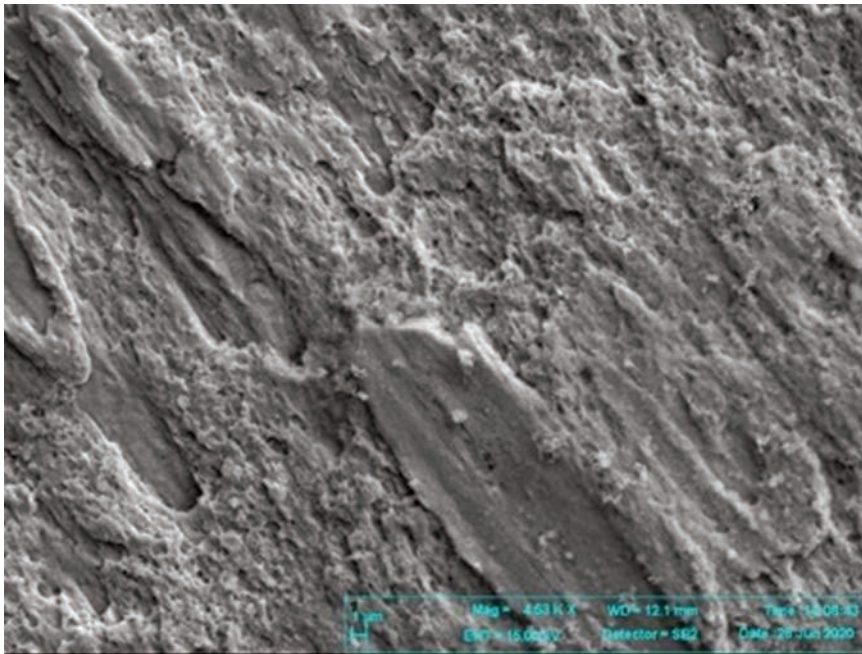
During SEM investigations, when fractured section surfaces were examined, it had been observed that the surfaces containing elongated dimples, which were formed in ductile type mainly due to torsional load of the surfaces as it is shown in Figure 10. It was observed that the dimensions of the dimples are approximate  $\sim 150\text{-}200\mu$  in the lateral direction.

Figure 10. The SEM image of the Shear-Neck.
