Lessons Learned from Collapse of Zumrut Building under Gravity Loads

Can Balkaya*‡

Abstract- The 11-story reinforced concrete Zumrut Building in Konya, Turkey collapsed on February 2, 2004. Ninety-two people died. This study was conducted to determine the mechanism of the collapse and identify lessons learned to avoid future disasters. Using structural drawings, material samples, and soil information obtained from the site, reasons for the collapse were investigated. A three-dimensional (3-D) structural model and analyses were performed using ETABSV8.11, and various possible critical cases were studied. The step-wise nonlinear analysis used to obtain the collapse mechanisms was an example of forensic structural engineering and revealed that the progressive collapse of the building was torsional, caused by decrease in structural system's capacity to redistribute gravity load after failure of a column. The lessons learned include the importance of project controls to reduce design and construction errors, ensure that construction and repairs are consistent with design intent, and changes are checked for safety and included in drawings. The importance of integrating architectural an

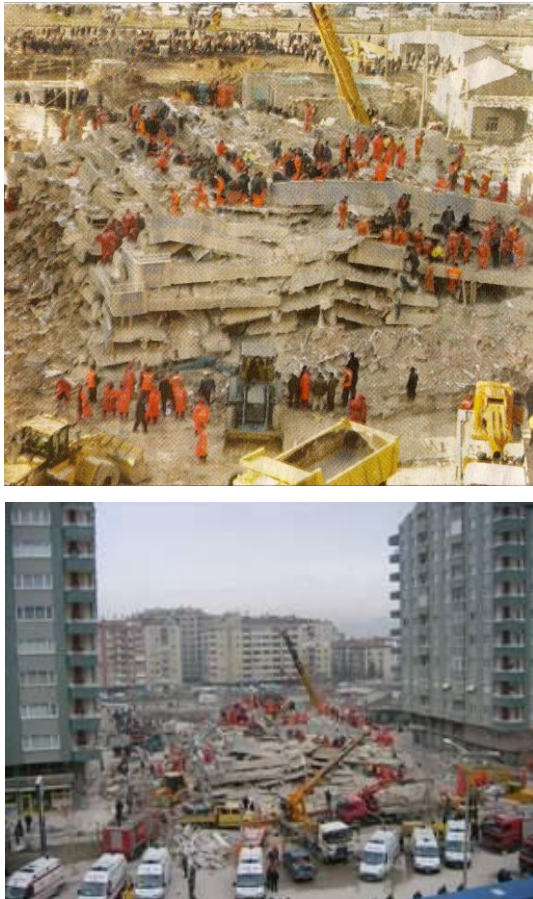
A 3-D structural model of the building was developed to identify the possible progressive collapse mechanisms using the general structural analysis program ETABSV8.11 [3]. The 3-D modelling of Zumrut Building was then analysed using step-wise nonlinear analysis. When a structural element reached its capacity, it was crushed. Analysis of the structural systems continued until the collapse mechanisms of Zumrut Building were identified. After studying many possible critical paths, the progressive collapse was found to be a torsional rotation collapse.

Fig. 1. Progressive collapse of Zumrut Building.

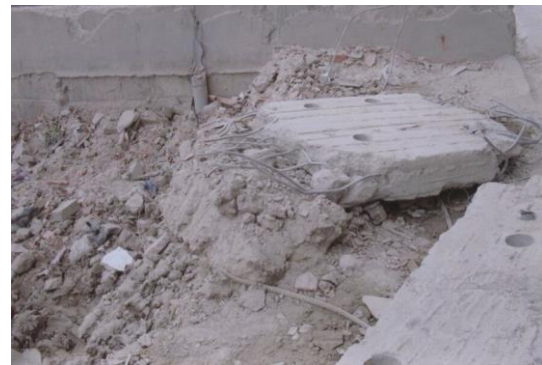
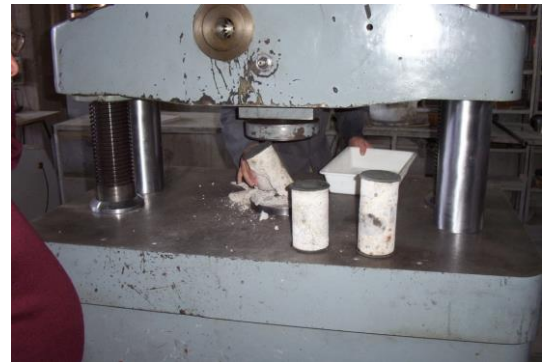
The sudden collapse of the 11-story reinforced concrete building was mainly due to poor construction and some design alterations that deviated from best practices for structural projects of this kind. The workmanship was not good. Concrete strength was lower than the project and code requirements for a reinforced concrete building. To determine the concrete quality used in the construction, many samples were taken on site after the collapse of the building. These samples were tested in the METU Department of Civil Engineering Material Lab, as shown in Fig. 2. The approved design compressive strength for the reinforced concrete was 160 kgf/cm^2 (C14). Test results of concrete cylinders taken from the site revealed a compressive strength of 80 kgf/cm^2 (C8). Since the samples were taken only from undamaged structural members, the compressive strength of damaged members is unknown.

Fig. 2. Concrete core samples.

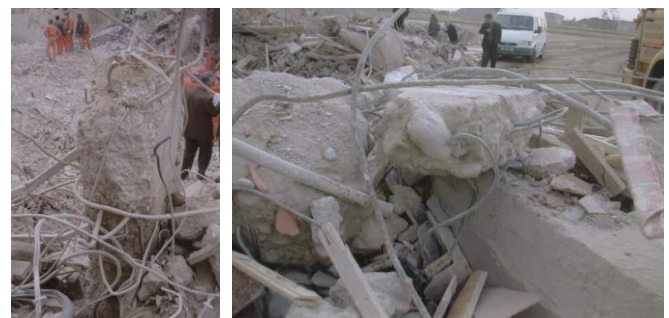
Based on material testing and site investigation, it was observed that the concrete gradation in the Zumrut Building was not uniform. The gradation did not satisfy Turkish or ASTM Standards. The quantity of the sand present was more than that of the gravel. Some aggregates were very big, as shown in Fig. 3, which does not comply with standards. Sand and gravel were taken partly from a river and were probably unwashed.

Fig. 3. Concrete gradation and cover.

reinforcements were replaced very close to the surface or inside the section (Fig. 3). On the other hand, the main longitudinal reinforcement of beams were replaced so closely that there was no enough space between the rebars for concrete. Beam dimensions in the approved structural design were 20/50 cm. This small concrete beam sections, as well as use of reinforcement type StI (2200 kgf/cm²) instead of StIII (4200 kgf/cm²), resulted in a large amount of reinforcements in the beam design. In such cases, reinforcements must be replaced in layers rather than as a single bottom reinforcement layer (Fig. 4) in order to form bonding between concrete and reinforcement. On Zumrut Building, placement of the large amount of reinforcements as a single bottom layer resulted in no bond or a very weak bond of reinforcement in the concrete. Thus, most of the beams did not properly transfer the forces due to the lack of a strong bond during collapse of building.

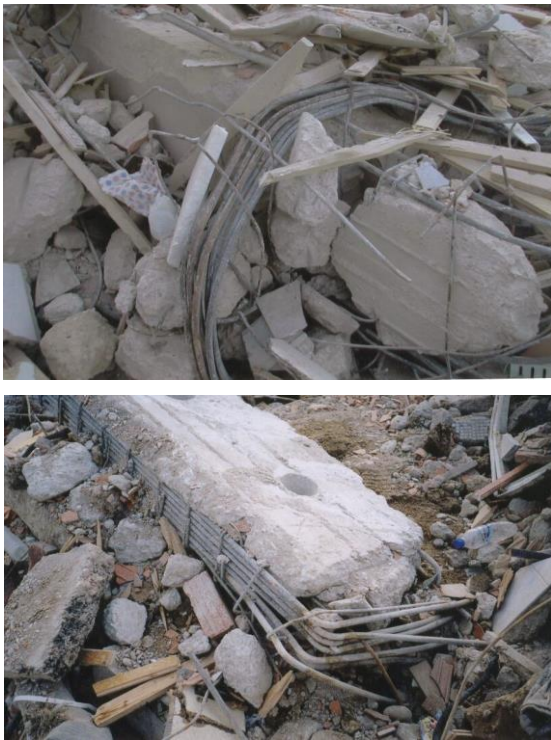
Fig. 4. Bond between concrete and reinforcement.

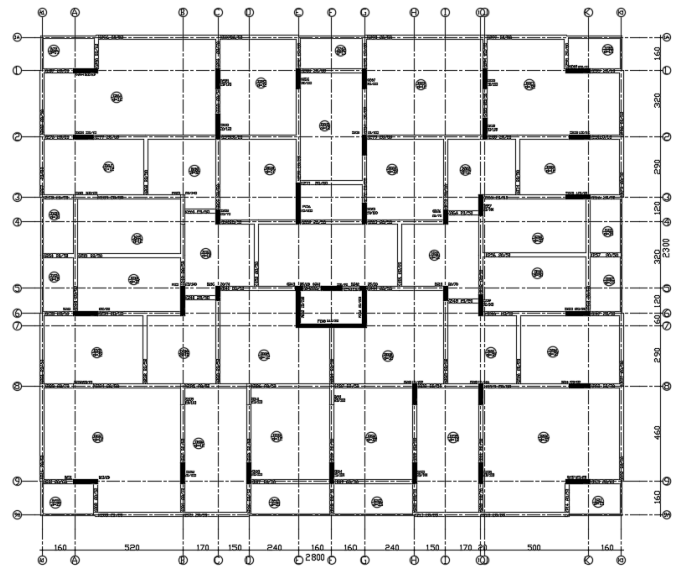
Fig. 5. Typical structural floor level of RC Zumrut Building.

The 11-story Zumrut Building was approximately 36 m high. The ground floor was 5.6 m high to accommodate shops, and the residential floors were 3 m high. Columns dimensions were generally 20/100 cm, 20/70 cm, and 25/100 cm (25/70 cm at the basement and ground floor levels). Beam dimensions were generally 20/50 cm. Reinforced concrete slabs were 12 cm. The rigidity center was at the right of the mid-part of the floor plan due to the shear walls of the elevator as shown in Fig.5.

torsional resistance of the building was very low. On the other hand, there were discontinuities in the structural frame systems in both directions. Most of the frames, as shown in the structural plan (Fig. 5), were single-span frames especially in the short direction of the building. There was no direct connection between the frames; they were discontinuous in both directions. Some of them were not even located in the same line as that of the axes. There were four flats on each floor, but as seen in the floor plan in Fig. 5, the layout was not symmetric, and flats had different construction areas. When the author asked why the four flats were not symmetrically located in the floors, the reason was given as the consideration of the percentage sharing of the landowners. All columns between the B and J axes in the plan shown in Fig. 5 were located in the same direction as strong directions.

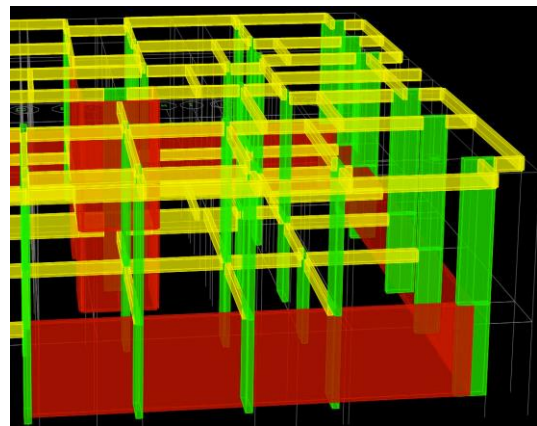
Fig. 6. Console part and beams located at out of frames at façade.

The floor areas were extended 1.5 m outside the frames all around the façade except at the ground level, as shown in Fig. 6. Between the columns around the exterior part of building, there are no beams. This may be due to architectural views as shown in Fig. 5 and Fig. 6. Thus, the frames were effectively not working, due to the lack of beams in the frame axes. The beams were connected to the frame columns using a cantilever beam and were located at the outer perimeter of the plan. This also resulted in the exterior frame column being subjected to large console load effects in the out-of-frame elevation. Corner columns were more critical. The outer parts of the building frames were working not effectively under lateral loads to transfer the loads when the stability of the building changed. Thus, the

- Locating floor areas in the console in some or all of the façade of a building is very common in Turkey to gain construction area above the ground level according to permissions in municipalities construction law. In such cases, frames do not properly transfer the forces under lateral loads or in cases of torsion due to a lack of beams between the columns. If these beams exist, they will probably pass through the rooms and corridors. For the structural continuity and transfer the forces alternative structural floor systems can be used, such as ribbed floors or flat-plate floor systems to integrate the architectural and structural system requirements. Otherwise, beams should be placed between the columns in the frame or the column lines should be put under console beams to construct a new frame at the exterior console part without closing the ground level from foundation to the top (not allowed in Turkey).

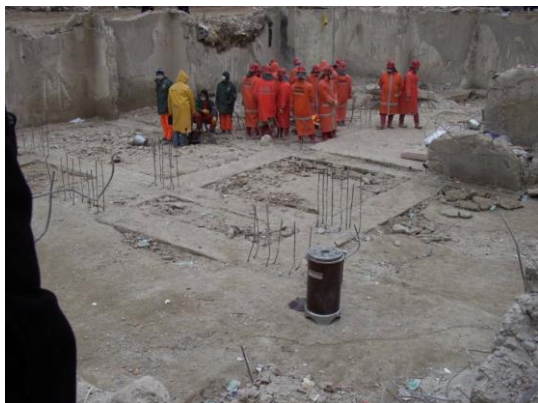
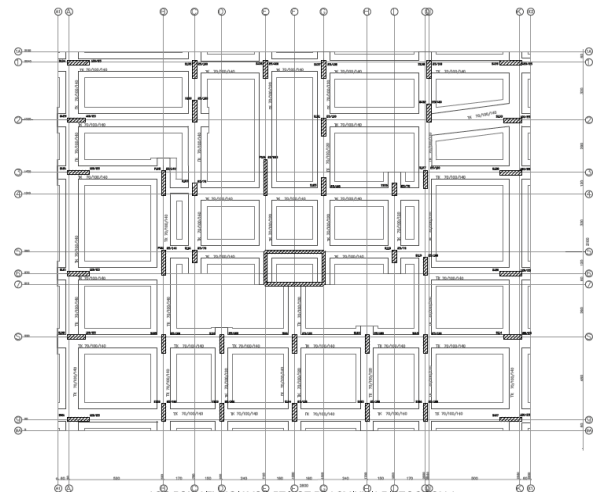
Fig. 7. Continuous foundation system in both directions.

The building foundation was a continuous foundation system in both directions, constructed in a grid system with shear walls around the perimeter of the basement (Fig. 7 and Fig.8). No damage was observed in the foundation after removal of the debris.

Fig. 8. Foundation plan.

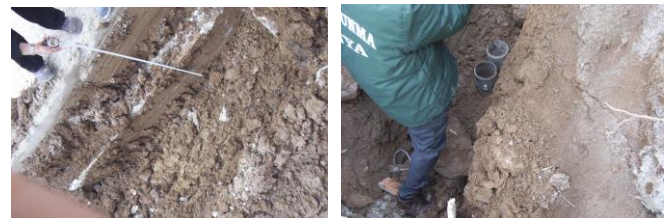
Soil samples were taken during the site investigation (Fig. 9). The soil in the project site was silty clay, and no groundwater and settlement problems were observed after the collapse of the building. Thus, it was concluded that the soil and foundation system did not have any major effect on the collapse of Zumrut Building.

Fig. 9. Soil samples and foundation depth.

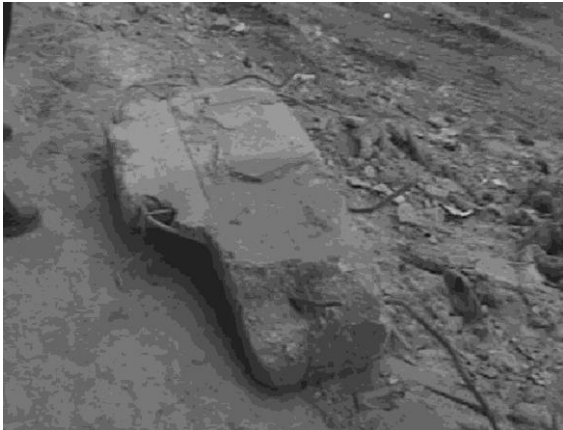
structural drawings as well as not checked for structural safety. During the removal of debris, a column of variable dimensions was also found at the ground floor (Fig. 10). The cross-section of the column size varied from 25/70 cm at the top to 25/40 cm at the bottom. This variation was probably to provide more spacing.

Fig. 10. Column found in debris with variable cross-section (Bottom part 25/40 cm, upper part 25/70cm) at the ground level.

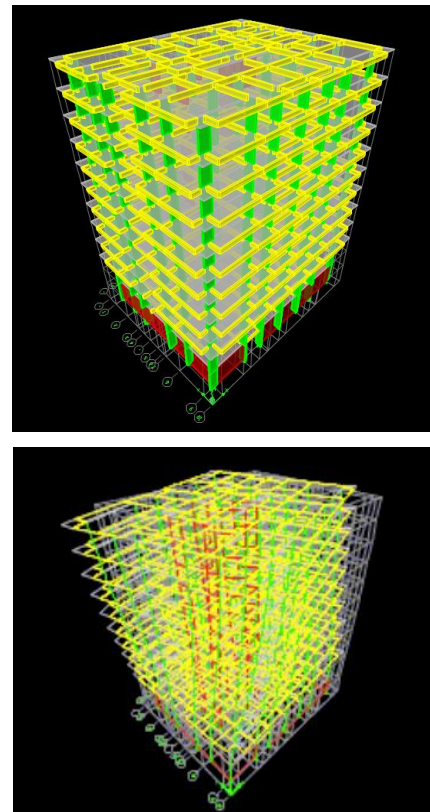
3-D modelling of Zumrut Building (Fig. 11) was analysed using step-wise nonlinear analysis [2]. Column capacities were calculated by using material quality obtained from test results. When a structural element reached its capacity, it was crushed, and analysis continued until the collapse mechanism was determined. The progressive collapse of the building was a torsional collapse (Fig. 12). Possible local failure mechanisms would cause a progressive failure of the story columns due to excess capacity on neighbouring structural elements. This story collapse resulted in a torsional motion. To obtain the torsional motion evidenced by the original collapse of Zumrut Building, many alternative potential collapse paths for the columns were studied.

The study revealed that if a column was crushed, the neighbouring column faced additional loads of 20%. Since most of the columns were near capacity—due to project and construction errors, and low-quality concrete—these additional loads caused progressive collapse of adjacent columns.

Fig. 11. 3-D finite elements modeling of RC Zumrut Building.

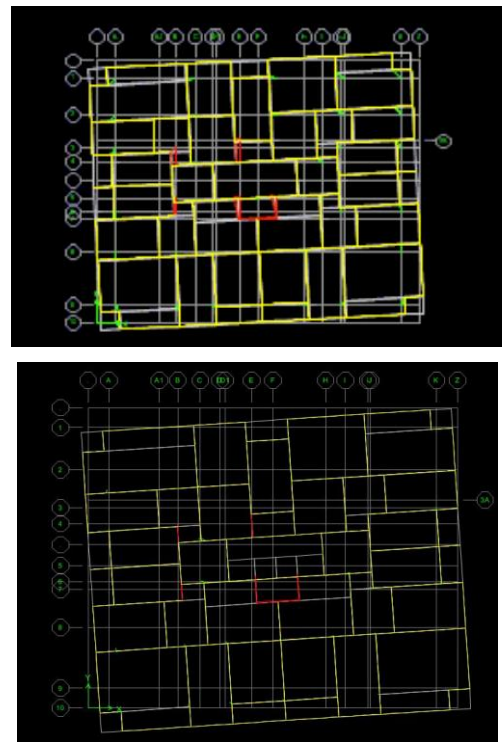
Fig. 12. Rotational/torsional collapse of Zumrut Building in plan view.

The building torsional capacity was very low, and structural frames were not continuous in both directions; discontinuities in the 3-D structural framing, and very low bonds in the RC beams, result in improperly redistribution of

the forces. The result was collapse of story level, progressive collapse of the upper stories and total collapse of Zumrut Building.

Thus, progressive collapse of Zumrut Building occurred due to loss of gravity load capacity to redistribute the load after the failure of a column. This was caused by a lack of frame continuity, capacity, and other mechanisms. Removal or crushing of a single column from a building such as this would cause it to collapse. To obtain the original collapse torsional rotation, many critical load paths were applied to the model. Depending on the column that was removed or failed the torsional rotation direction and collapse angle and mechanism were different. Each column was removed alternately from each level, and then capacity checks and load distributions were done for the new situation. In this manner, the progressive collapses of each floor level were obtained. After considering many alternative cases, the reason for the collapse of Zumrut Building was obtained in the analysis. This was a forensic structural engineering study to investigate and determine the causes of structural failure by using 3-D nonlinear finite element analyses.
