# The aftermath of 2023 Kahramanmaras earthquakes: evaluation of strong motion data, geotechnical, building, and infrastructure issues

## Abstract

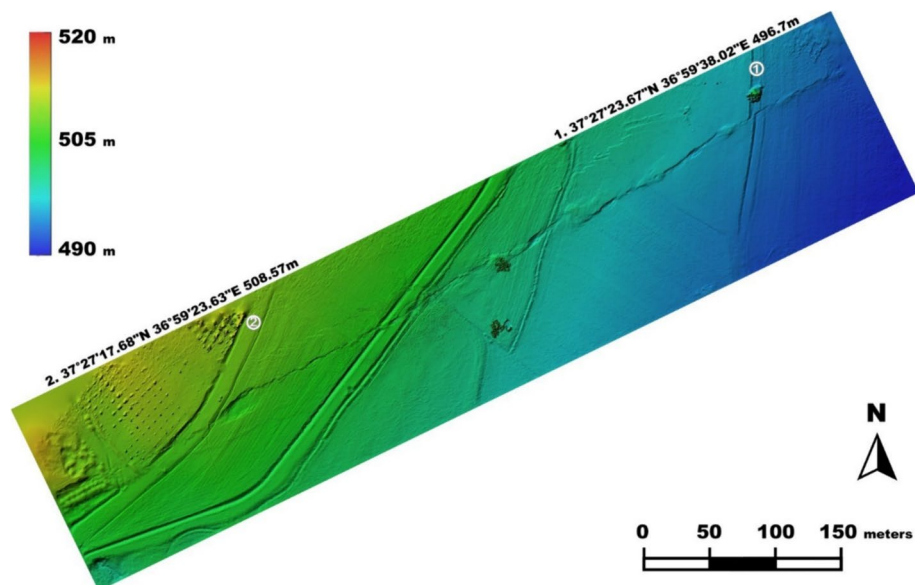
**Fig. 4** Depiction of fault surface rupture modeling using drone imagery in the Sekeroba region

displacement range (Fig. 4). The drone modeling study conducted in Sekeroba measured the highest displacement at 4.13 m. This Mw7.7 earthquake exhibited a left-lateral strike-slip fault mechanism consistent with the characteristics of the DAFZ fault system.

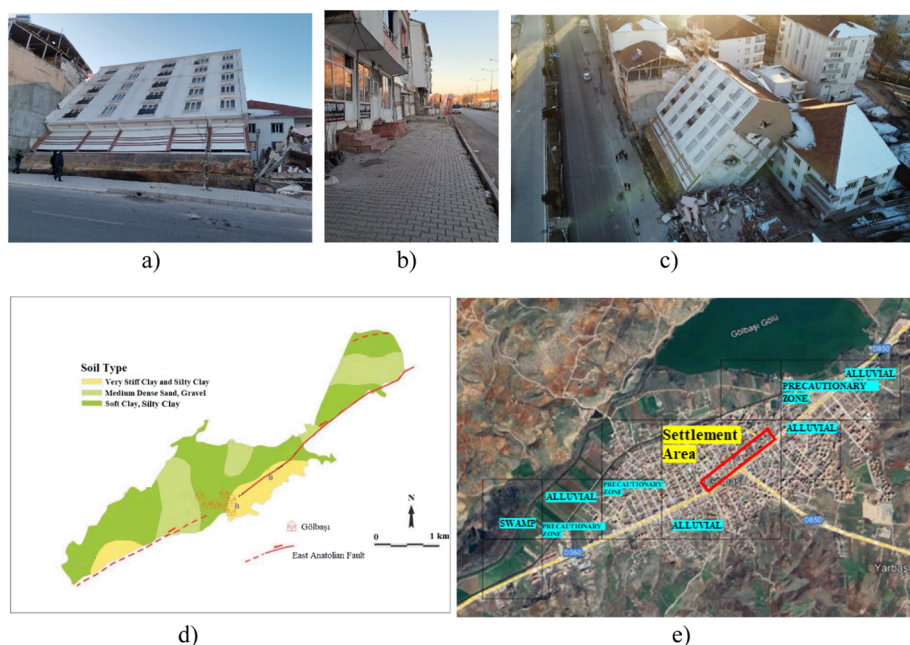
**Fig. 15** Problems observed in foundations **a**, **b**, and **c** in different soil types **d** in Golbasi, Adiyaman **e** (**d** and **e**, modified from Akil et al. 2008)

The Golbasi province is characterized by two distinct soil zones: alluvial soil deposits and swamp soil deposits (Akil et al., 2008). The Kahramanmaraş earthquake resulted in settlements and upheavals in the alluvial area. Analysis of the soil group distribution map (Fig. 15d) reveals that the southeastern part of the district is predominantly composed of very stiff, highly plastic clay material, while the district as a whole consists mostly of fine-grained, low-plasticity soft clay and medium-density sandy material. The water table fluctuates between 0.65 m and 3.50 m. According to studies conducted by Akil et al. (2008), the groundwater level is high, and there is a moderate risk of liquefaction, particularly in sandy and some gravelly areas. These areas are susceptible to liquefaction, which can lead to surface damage. Given the high groundwater level, presence of alluvial soils, moderate liquefaction risk levels, and the district's location in an earthquake zone, these areas have been classified as precautionary zones (Fig. 15e). The Kahramanmaraş earthquakes resulted in significant surface and structural damage in the alluvial soils in these designated precautionary zones.

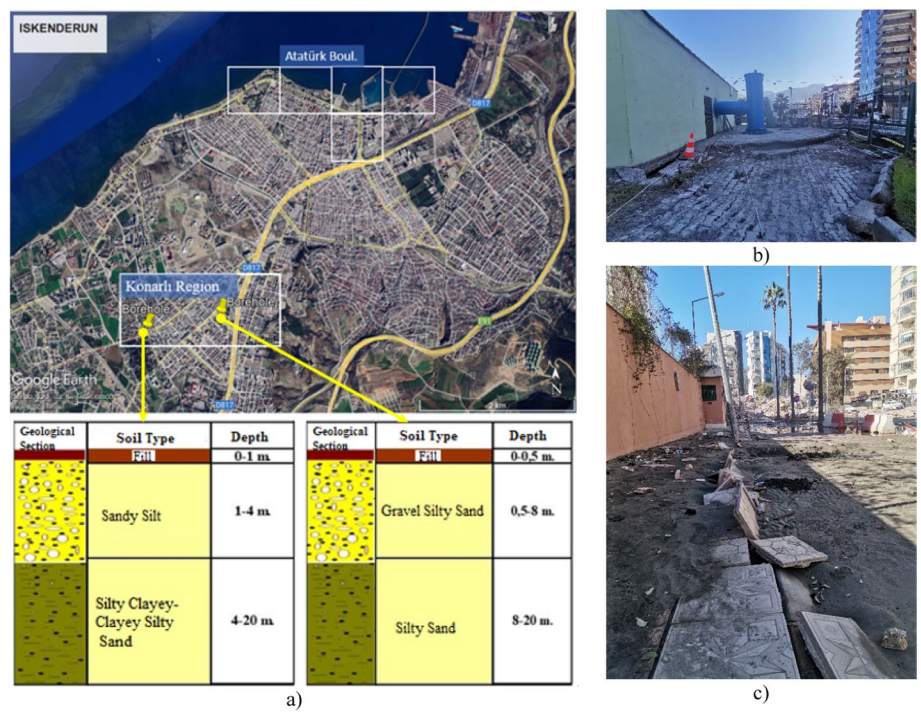
Another area that experienced significant damage in Hatay is Iskenderun. Figure 17 shows a typical soil profile for Iskenderun and the effects of liquefaction on buildings and roads. A sample soil profile was defined using two soundings made in the Konarlı District of Iskenderun (Toktanis and Over 2021). Intense sand and silt units were observed. During reconnaissance studies, serious damage was observed on buildings and roads along Atatürk Boulevard (Figs. 17b and c). The rainwater collection system in the area was damaged by liquefaction and was rendered unusable after the earthquake (Fig. 17b). Settlement was observed in buildings along the route, and significant lateral spreading was also noted (Fig. 17c).

Fig. 17 Damages along the Ataturk Blvd in Iskenderun and typical soil profile Konarli District as reported by Toktanis and Over (2021)

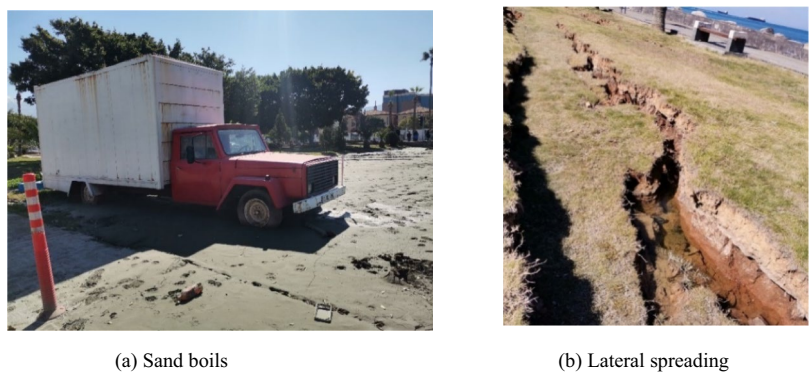
Fig. 18 Liquefaction-induced ground deformations in Iskenderun/ Hatay

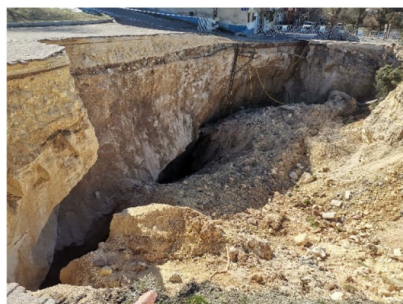
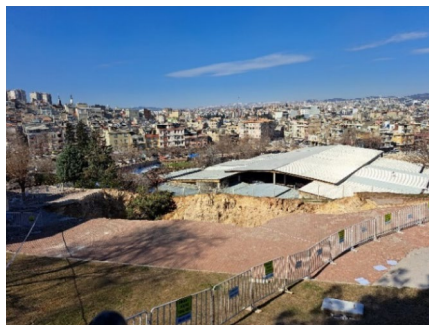
Slope failures and rockfalls occurred at many locations in the region, with some landslides causing damage to structures and lifelines. Figure 19 shows examples of landslides observed in earthquake-affected areas. The landslide in Gaziantep/Sahinbey (Fig. 19a) also puts surrounding structures at risk. Many small shops at the bottom of the hill face immediate landslide risks, prompting evacuation procedures following the earthquake. Similar instances, such as the one shown in Fig. 19b, were encountered in different regions along the investigation route. Road closures occurred in these areas immediately after the earthquake, but the roads were reopened after clearing the rocks and making some repairs. However, due to the potential for additional slope movements triggered by subsequent tremors or precipitation, ongoing monitoring and precautionary measures are necessary.

(a) Gaziantep/Sahinbey landslide

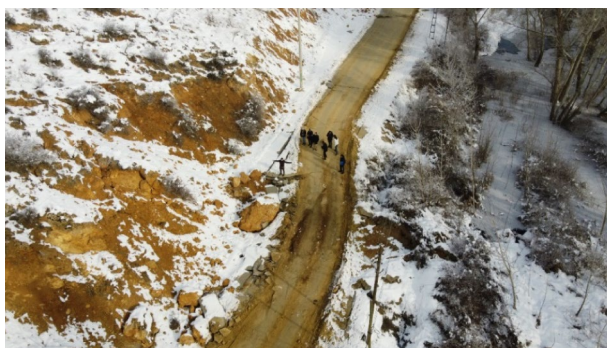
(b) Ekinozu landslide and rockfall

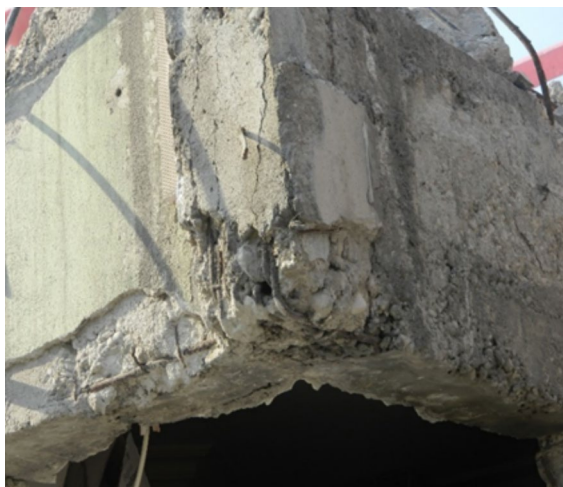
The collected building data included structures with construction permits, indicating that 86.7% of the building stock in the region consists of reinforced concrete structures. While the high acceleration values recorded during the earthquakes are primarily considered the cause of structural damage, factors such as structural system design, construction defects, and lack of engineering services for reinforced concrete buildings in the region are identified as the most significant contributors to the severe damage. Upon evaluating the structural damages in the region, the following deficiencies and defects were commonly observed in buildings believed to have been constructed before 2000 (Fig. 20):

**Fig. 20** Problems observed in the quality of concrete and the availability of smooth surface reinforcing steel

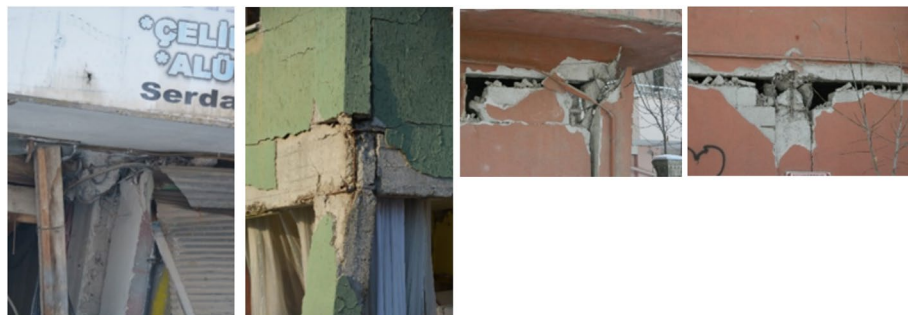
One notable issue in the damaged structures throughout the region is the insufficient longitudinal reinforcement in the cross-sections. It was observed that transverse reinforcements were inadequately placed both along the cross-section and at the beam-column joints. Considering the low concrete quality observed in the damaged structures, the lack of transverse reinforcement to withstand shear effects has been concluded as one of the most significant reasons for the damage (Fig. 21).

**Fig. 21** Problems observed with insufficient beam-column joint details

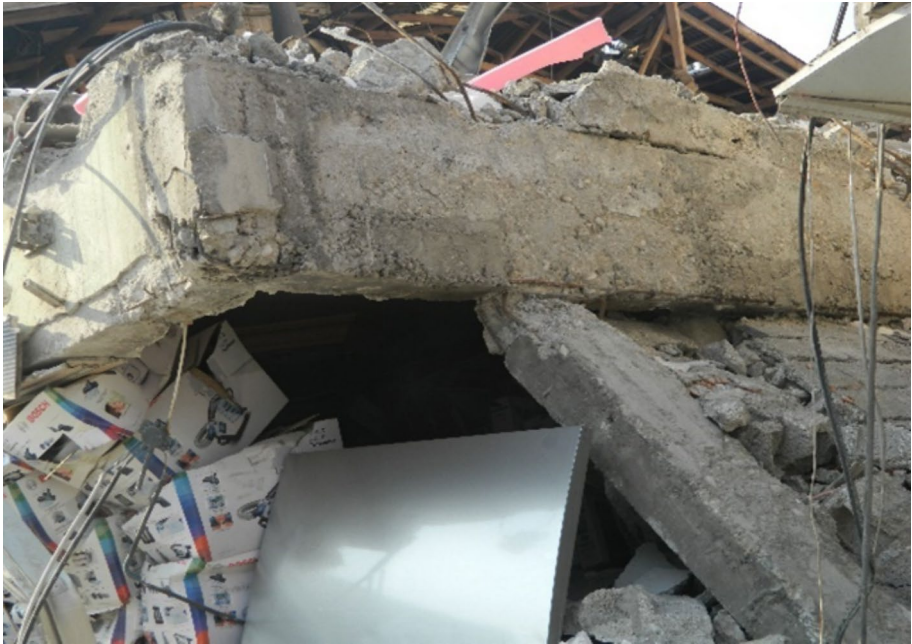
- Contrary to the philosophy of earthquake-resistant building design, which emphasizes the “strong column-weak beam” approach, buildings estimated to have been constructed before 2000 often exhibited the opposite. In this incorrect application, column sections were minimized while connected to larger beams. As a result, buildings experienced intense damage due to the collapse of heavily constructed slabs, as columns failed before beams under the strong ground motion, leading to significant casualties (Fig. 22).
- Many buildings were damaged due to the irregularity of soft/weak stories, such as the relatively high design of entrance floors, the removal of infill walls for commercial

**Fig. 22** Observed design problem as strong beam-weak column

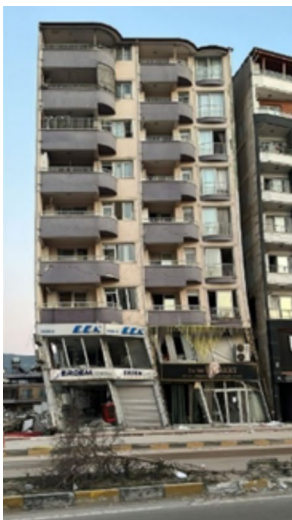
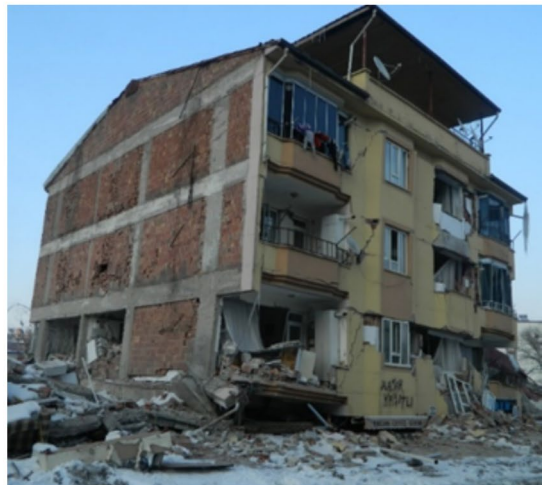
**Fig. 23** Design problem observed as soft/weak stories

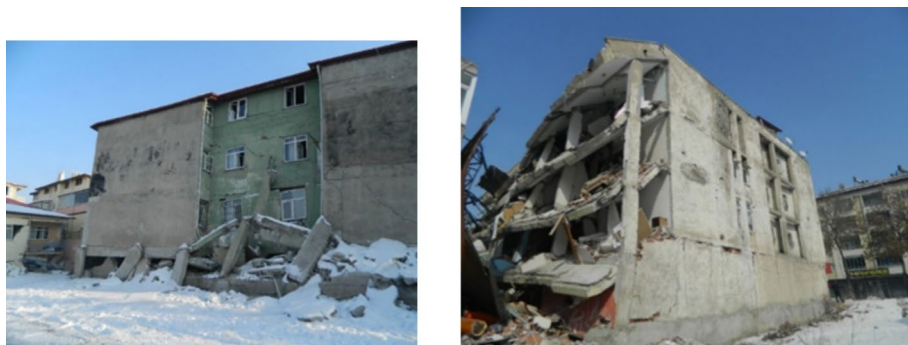
- Buildings that experienced significant permanent displacement of their structural elements and partially collapsed due to the earthquake are classified as “urgently to

**Fig. 24** Partially collapsed buildings

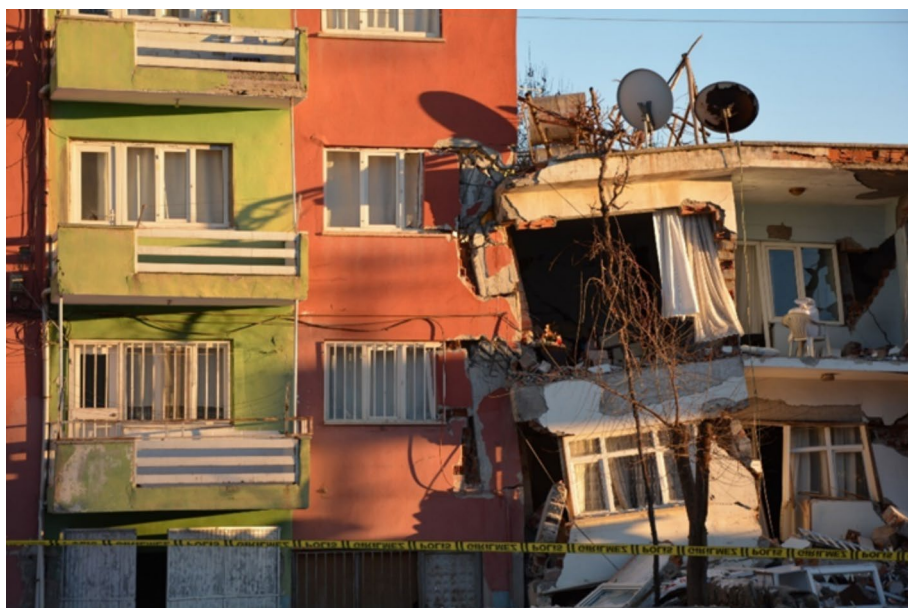
**Fig. 25** Pounding effect observed in adjacent buildings

- It has been observed that buildings constructed adjacent to each other with insufficient expansion joints suffered damage because of collisions under strong ground motion. This structural irregularity, observed in adjacent buildings with different floor levels and referred to as the “Pounding Effect,” can cause severe damage, even total collapse, in structures with different dynamic characteristics (Fig. 25).
- Despite the extensive damage, there are also structures in the region that survived the earthquakes without any damage (Fig. 26).

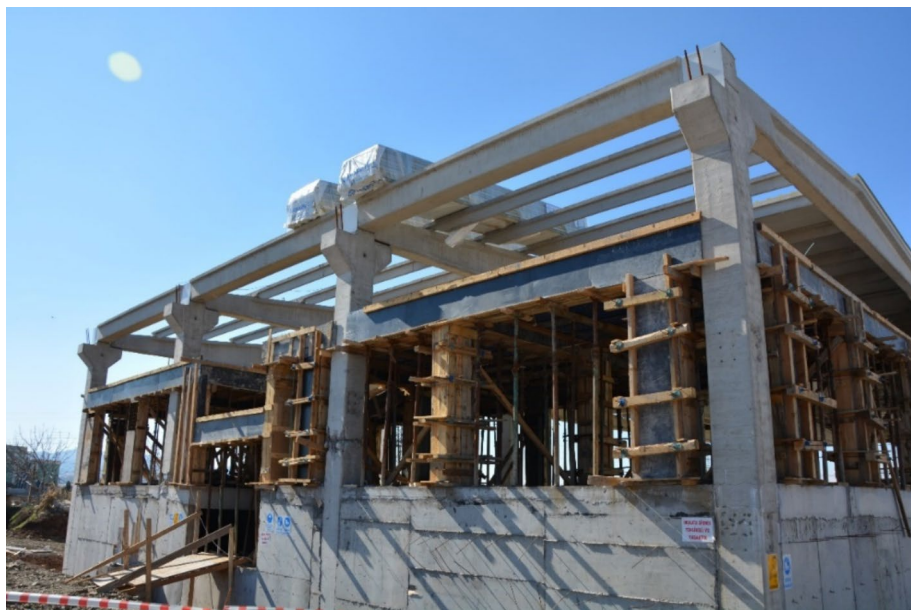
**Fig. 27** Structural damages (buckling in column reinforcements) in a new construction in a textile facility in Kahramanmaraş

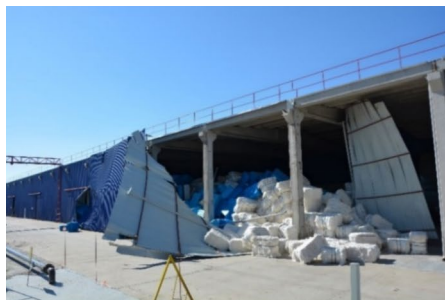
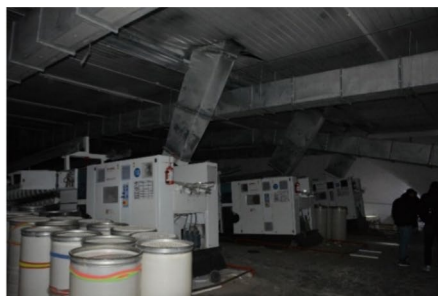
**Fig. 28** Damages to non-structural elements (siding damage and machine-equipment damage) in a textile facility in Kahramanmaraş

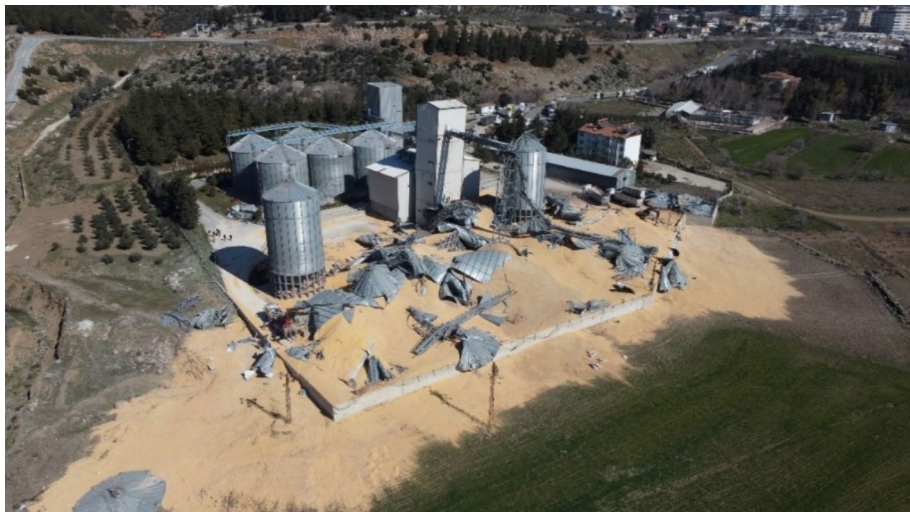
**Fig. 29** A food facility in Gaziantep Nurdagi with damaged corn and wheat silos

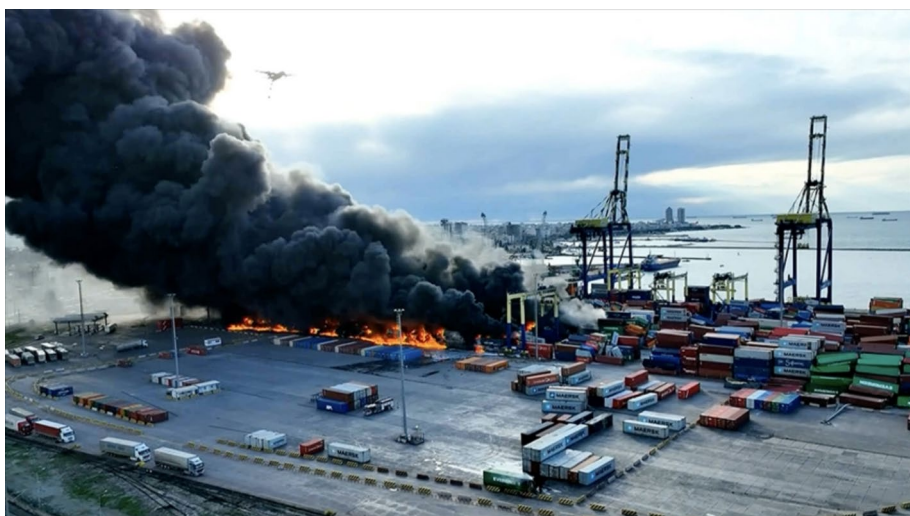
**Fig. 30** Fire in the Iskenderun Port after the earthquake (Anadolu Agency [2023a](#))

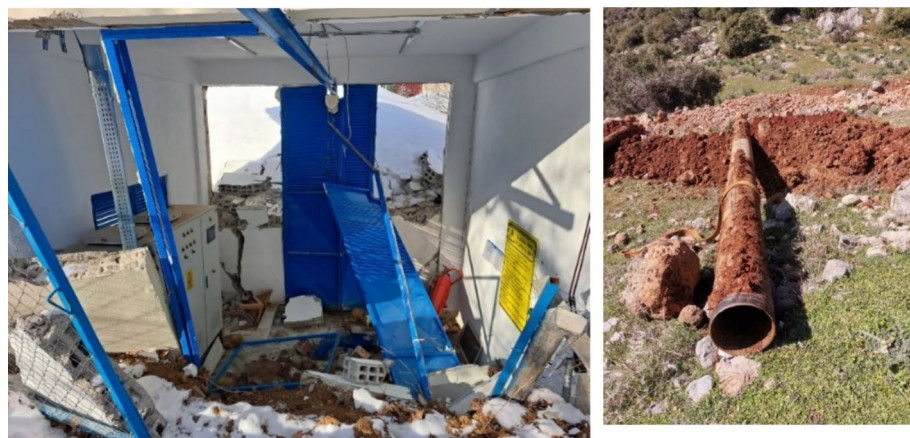
Figure 31a shows the damage to water systems caused by faulting in the earthquake zone, where a drinking water pump station near the fault was seriously damaged, and the connection pipes were broken. Figure 31b shows a ductile pipeline damaged by faulting near Nurdagi. While the pipe body itself remained intact, separations occurred at the connection points. Figure 32 illustrates the damage caused by liquefaction at the stormwater and sewage elevation station on Ataturk Boulevard in Iskenderun. Figure 33

**Fig. 31** Damages in water systems caused by fault movement

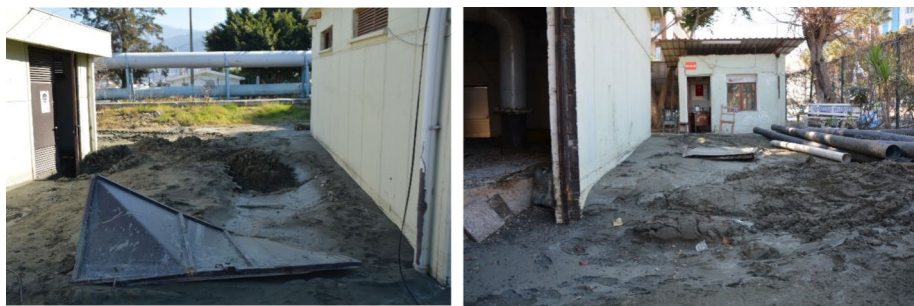
**Fig. 32** Damages caused by liquefaction at the sewerage and storm water elevation station in Iskenderun

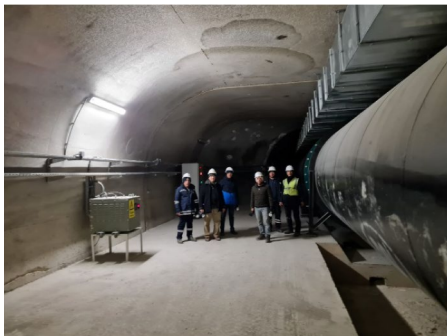
**(a)** Duzbag drinking water transmission line and tunnel

presents observations from the Duzbag drinking water transmission line and tunnel. This system features a 2.6-m diameter steel conduit pipe running through a 3.5-km tunnel. Some damage occurred in the tunnel and pipe support system, as shown in Fig. 33. The tunnel, designed to protect the pipe and facilitate maintenance, functioned as intended, preventing damage to the pipe itself. The pipe responded to axial deformations with small movements at the connections. Following intensive repair and inspection efforts by GASKI and its support teams, water flow was restored to the city from the transmission line within three weeks after the earthquake.

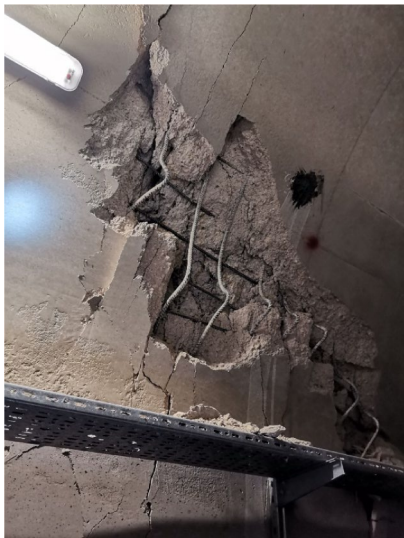
**(b)** Partial damage to the tunnel

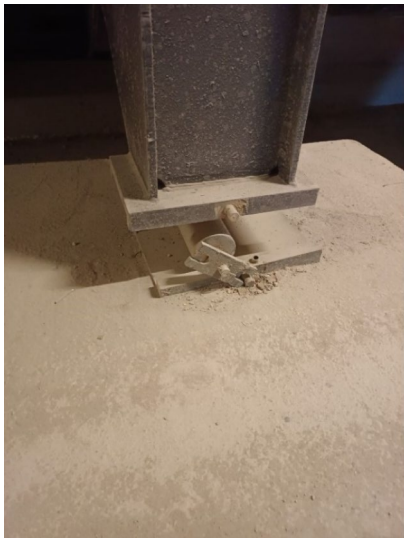
**(c)** Damage to the pipe support

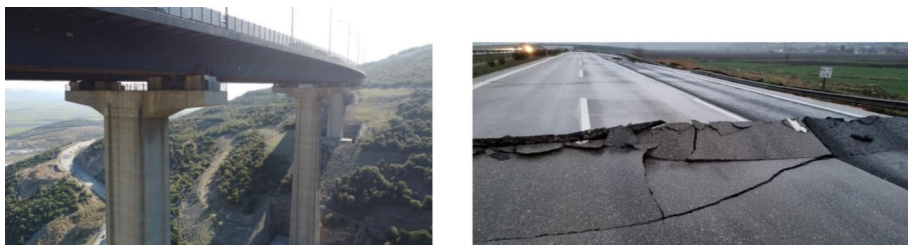
**Fig. 35** Viaduct on TAG Highway: no damage to deck, columns, or supports; Tarsus-Adana-Gaziantep Highway: observed damage

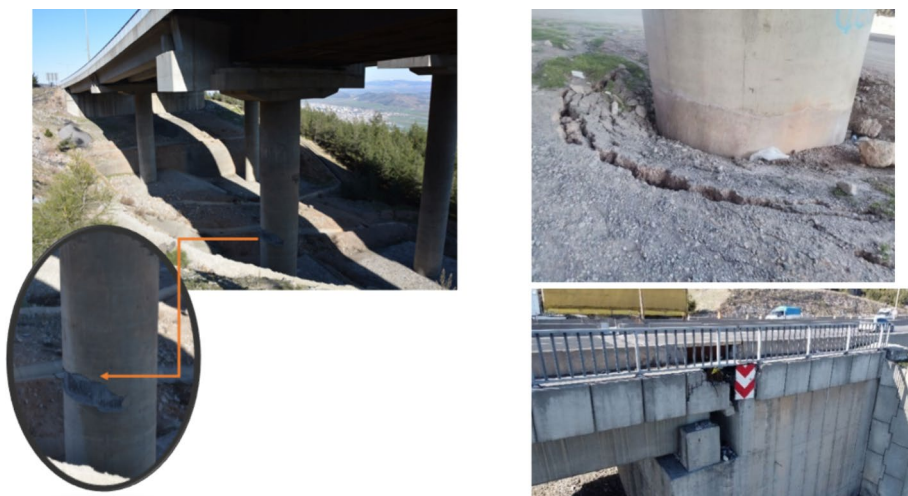
**Fig. 36** Damage observations on TAG highway viaduct

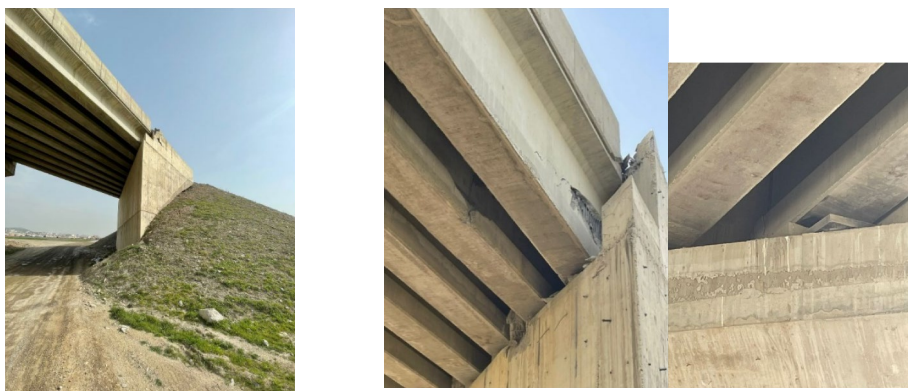
(a) Damage at the top edge of the abutment

(b) Nurdagi railway bridge: beam damages at the side abutment

**Fig. 37** Nurdagi-Railroad bridge damages

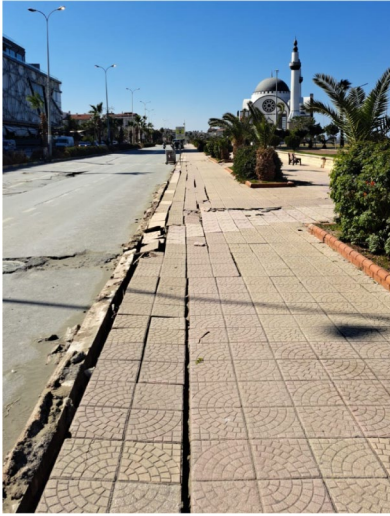
(a) Damages on the road and pavement due to liquefaction in Iskenderun

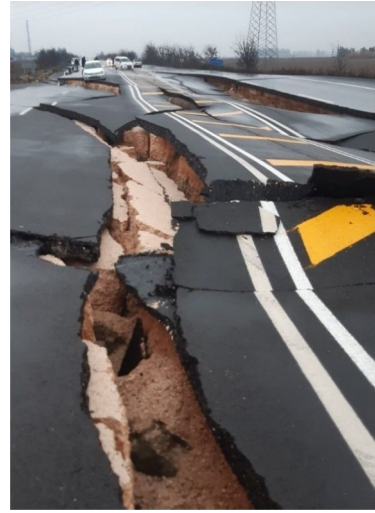
b) Hatay-Reyhanli road damages

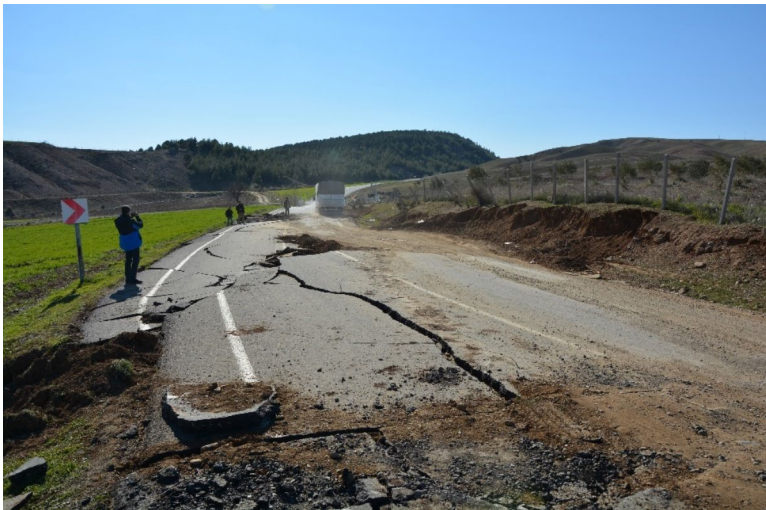
**Fig. 39** Damage observations at Pazarcik—Tevekkeli village road and fault intersection

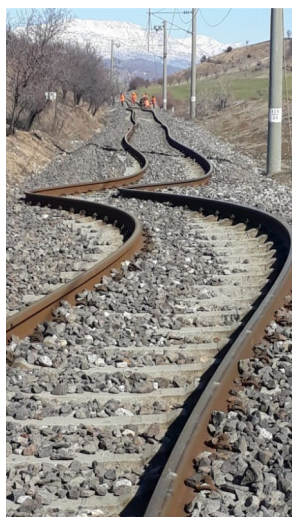
(a) Golbasi-Malatya railway line

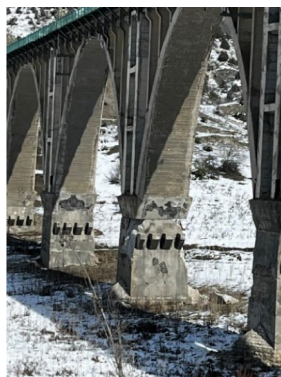
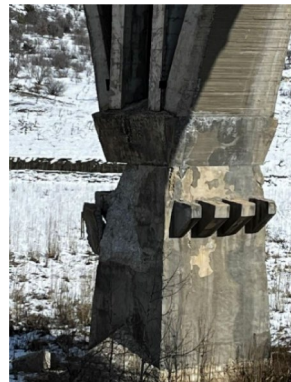
b) Railway bridge - artwork and pier damage

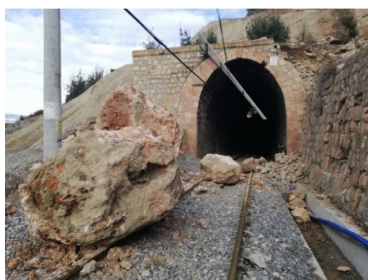
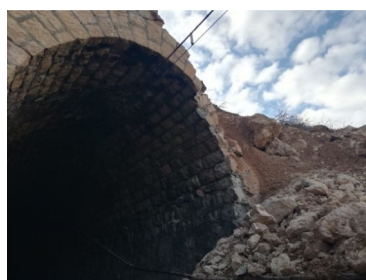
(c) Closing of the tunnel entrance and damage to the tunnel structure due to rockfall and landslide at the railway line tunnel entrance

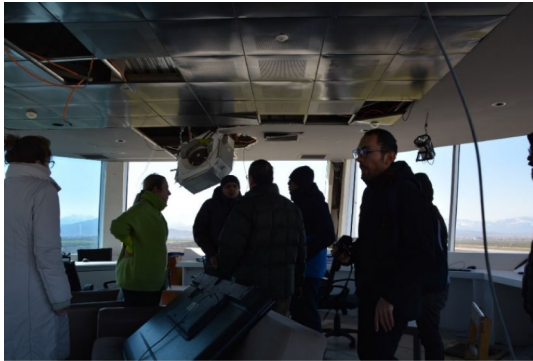
(a) Non-structural damage to the tower structure

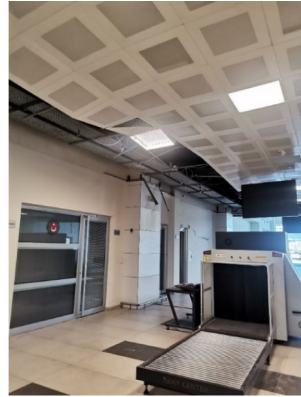
(b) Main building suspended ceiling damage
