Engineering Failure Analysis

Fracture and failure analysis of the trainer aircraft rudder pedal hanger

This study analyzes the T-38A Talon twin-jet trainer aircraft rudder pedal hanger damage due to the fracture that has been identified at the clevis surfaces where the tension rises. The hanger has the function of swinging the rudder pedal under irregular tension loads. The fractured hanger material is magnesium AZ91C-T6 cast. The composition of the hanger is 90% Mg, 8.1–9.3% Al, 0.4–1% Zn, 0.3% Si, 0.13% Mn, 0.10% Cu, and 0.01% Ni. The average hardness value of the material was measured as 77 Hardness Rockwell-C (HRC). The oxygen and chloride pollutants had been observed under Field Emission Scanning Electron Microscope (SEM) and Energy-Dispersive X-ray Spectroscopy (EDX). The mentioned pollutants were considered as the main factors for decreasing the corrosion strength. The mentioned corrosion augmented the crack propagations from multiple origins of the rudder pedal hanger. The fracture and failure analysis results demonstrate that the corrosion pitting associated the fatigue under the influence of repeated loads. Eventually, after the crack had grown catastrophically, the res

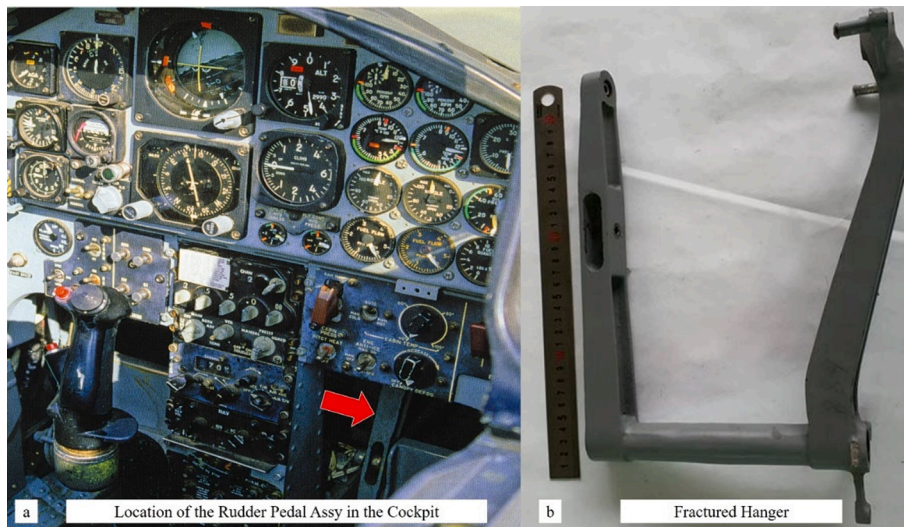
Fig.2. 2.a. Location of the rudder pedal assy in the T-38A Talon twin-jet trainer aircraft, 2.b. Fractured hanger.

T-38A Talon twin-jet trainer aircraft's cockpit panel and the rudder assy as shown in Fig. 2a [15] and the removed rudder pedal hanger is shown in Fig 2b.

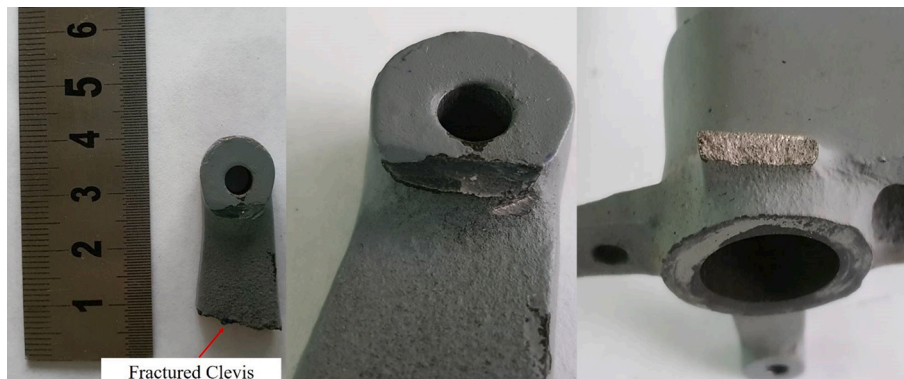
Fig. 3. General images about the fracture.

In the “canopy & ejection” shop, the whole rudder pedal assy was disassembled. As shown in Fig. 3., it was observed that the hanger was fractured into two pieces in the clevis where the thickness is relatively narrow and close to the radius section stress concentration is high.

The magnesium AZ 91C-T6 cast is a member of AZ91 alloy family. This family is known with low creep, abrasion resistance, elastic modulus, and ductility besides a high corrosion rate features [17]. It is considered that the hanger was heavily corroded and basically the fracture was based on the corrosion. Also, fretting corrosion was effective.

- The maintenance staff was informed for controlling the remaining hangers with magnesium alloy.
- The remaining rudder pedal hangers were controlled for mechanical damages and imperfections.
- The hanger’s material changed from Magnesium Alloy AZ91C-T6 cast into more corrosion-resistant material as Aluminum Alloy A201-TT.
- A new type of hangers are installed following the TCTO (Time Compliance Technical Order).

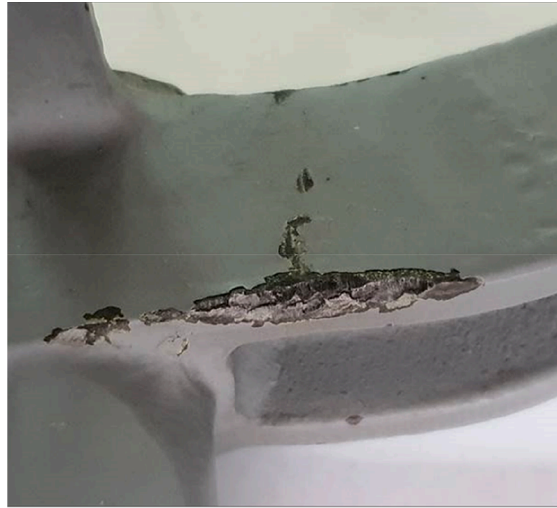
Fig. 4. Ratchet marks on the fractured surface.

It was observed that the ratchet marks had been formed by the intersection of fatigue cracks propagation from multiple origins. It was mentioned earlier that the hanger is operated under repeated loads. And it can be claimed that the cracks were intensified by the repeated loads. In Fig. 4. the ratchet marks that are parallel to the overall direction of crack propagation can be visually observed.

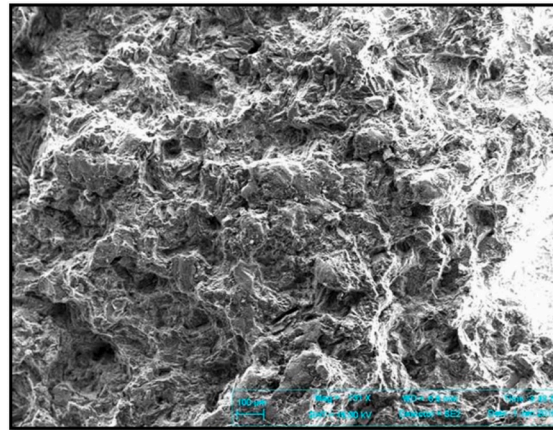
Fig. 5. The micrograph of the corrosion pits.

During investigations, a sample from the fractured part was metallographically prepared for the optical Field Emission Scanning Electron Microscope (SEM) and Energy-Dispersive X-ray Spectroscopy (EDX) investigations. It was determined that approximately 60% of the fractured surface had a brittle structure along the grain boundaries and cleavage planes with corrosion damage. The pits are shown in Fig. 5. influenced the crack propagation from the origin site towards the zone of hanger clevis where the fracture occurred. It was also observed that, from the lowest point of the crack where the wall thickness decreases, the transverse fracture had started to propagate in both directions and eventually broken the hanger clevis.

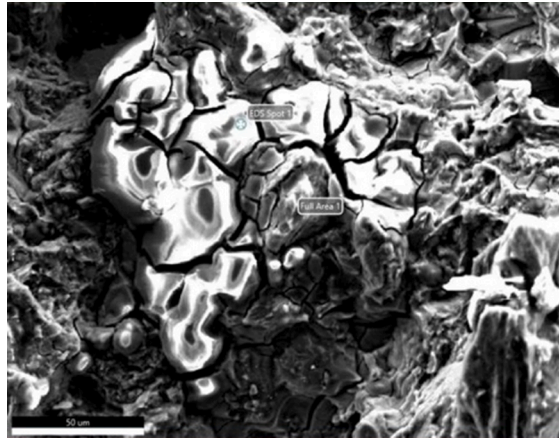
Fig. 6. The corrosion pits formed in the fracture section.

After high magnification examination, the remaining surfaces were found to have ductile pits formed by the effect of the repeated load as is shown in Fig. 6.

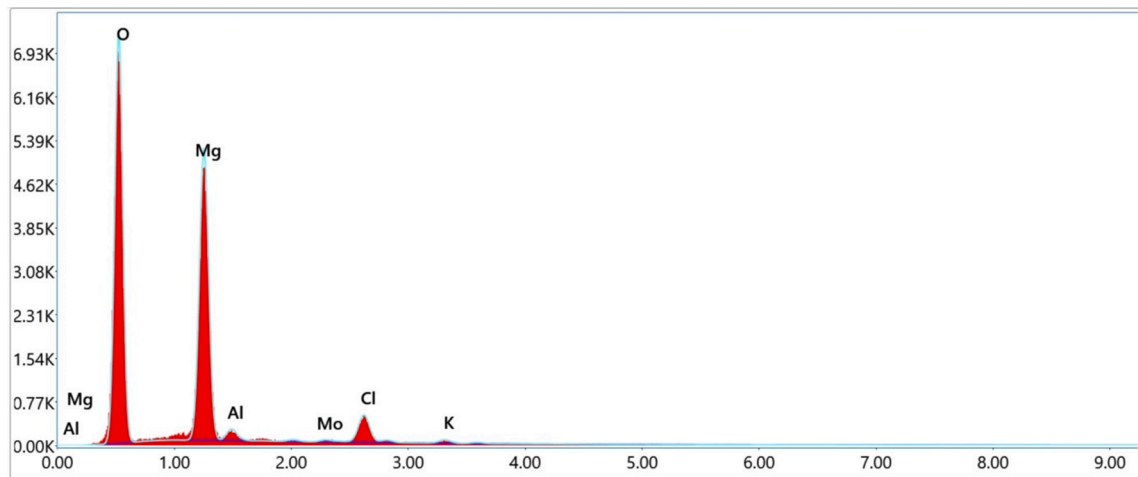
Fig. 7. Element spectrum of the hanger.

As a result of the elemental analysis Cl (Chlorine) and element O (Oxygen), which reduce the corrosion resistance, were found on the fracture cross-section surfaces as is shown in Fig. 7.

When the obtained findings are evaluated; from the clevis area of the hanger part where the stress concentration rises, it was concluded that the ambient atmosphere and time combination suffered corrosion damage and the remaining section was broken by not enduring the repeated loads.
