Engineering Failure Analysis

Failure analysis of J85-CAN-15 turbojet engine compressor disc

This paper analyzes the J85-CAN-15 engine damage due to fracture of the compressor disc 8th stage dovetail post. An Inner Object Damage (IOD) phenomenon was identified. The damaged compressor disc material is Incoloy 901 forging. The composition of the disc is determined as 42.7%-Ni, 34%-Fe, 13.5%-Cr, 6.2% Mo, 2.5%Ti, 0.1%-Cu, and 0.05%-C. The average hardness value of the material is 44 HRC. The burrs have been observed under Field Emission Scanning Electron Microscope (SEM) and they are considered as the origin of the fatigue on the engine compressor disc. The metallurgical analysis results show that manufacturing defect was propagated under the repeated low and high cyclic loads.

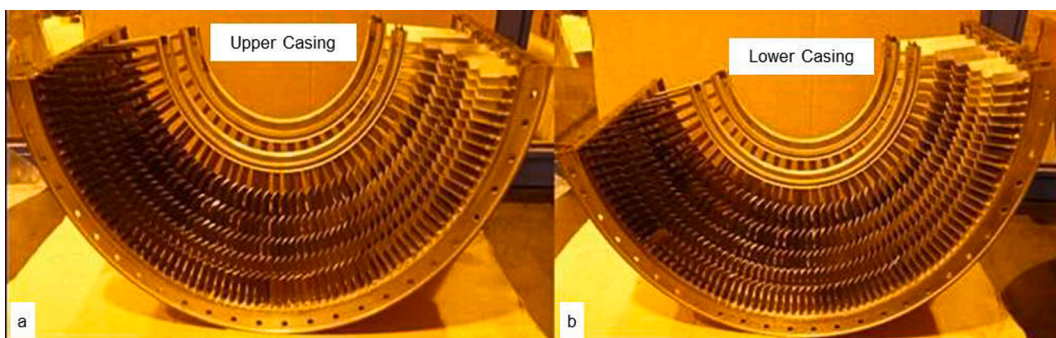
In the shop, the whole engine was disassembled. Firstly upper casing assembly as shown in Fig. 3.a and lower casing assembly as shown in Fig. 3.b were examined in terms of seal gap, sector vane assembly and clearance, vane sector tip clearance measurements, and incorrect assembly of vane sector. No defect has been detected on both casing assemblies.

Fig. 3. a. J85-CAN-15 Engine Compressor Upper Casing Assembly, 3.b. J85-CAN-15 Engine Compressor Lower Casing Assembly.

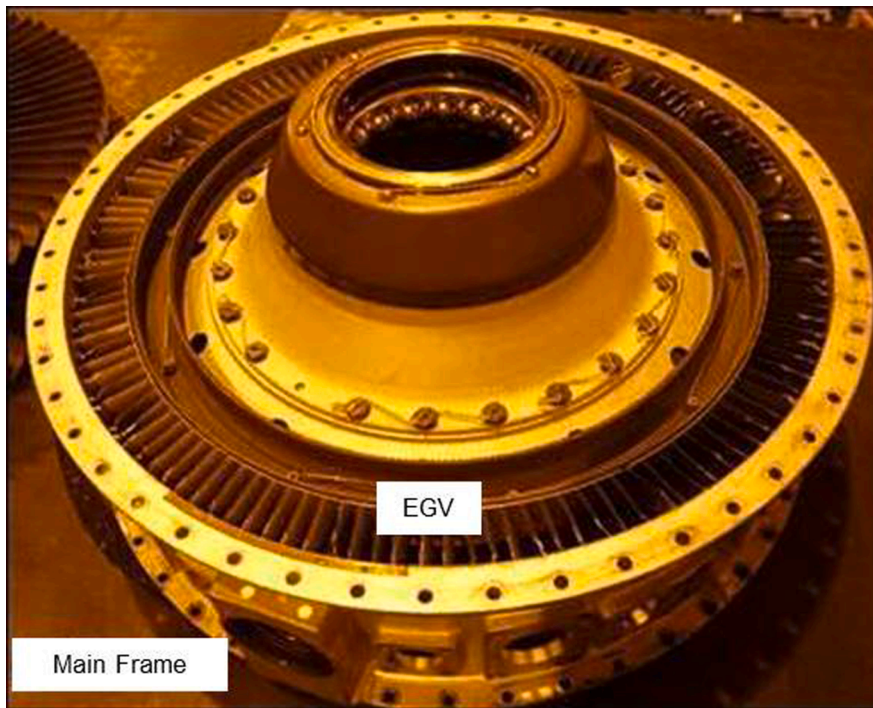
After casing assemblies, the Main Frame assembly and Exit Guide Vane (EGV) that are shown in Fig. 4, were inspected in terms of debris originated malfunctions. No malfunctions and defects were encountered during the inspection.

Fig. 4. Main Frame and EGV.

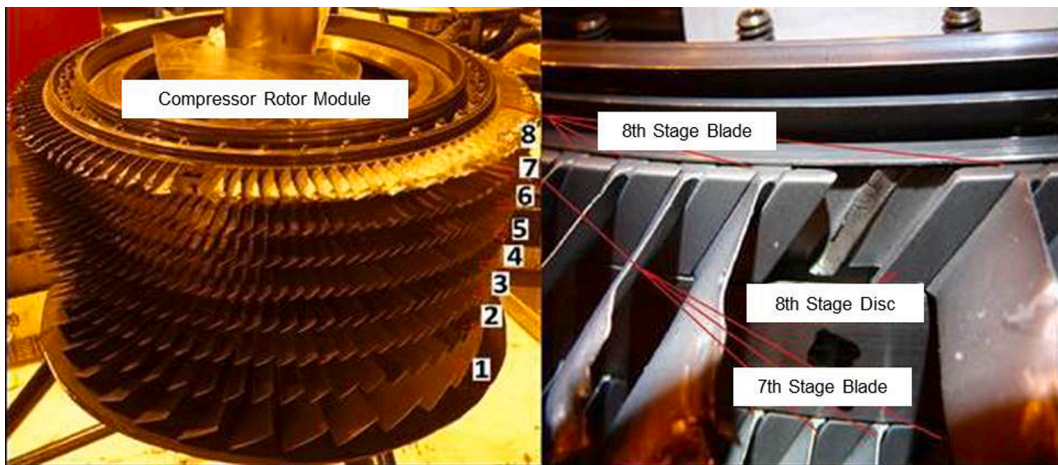
Respectively, the next assembly was the compressor rotor module. The controls were made in terms of clearance dimensions of discs, spacers, driveshaft, blades, and blade tips belonging to the compressor rotor module. No defects were detected, from 1st to 7th stage blades of the compressor discs. But on the blades on the 8th stage, the fractures are significantly identified as they can be seen in Fig. 5. It is considered that the most probable reason for the fracture is the removal of the blades from their places because of the damaged dovetail post.

Fig. 5. Assembly of Compressor Rotor Module and 7th, 8th Stage Disc Blades.

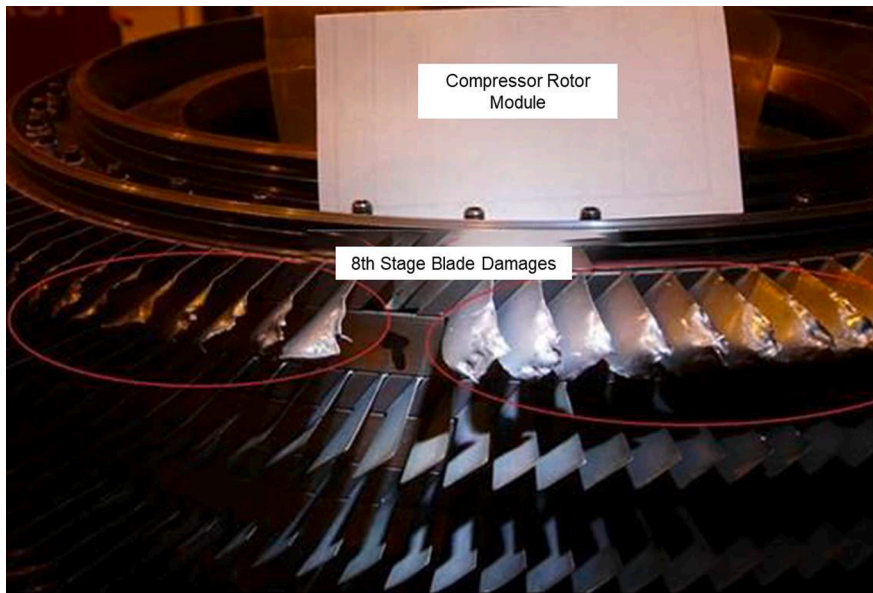
Almost all 8th stage compressor rotor module turbine blades tip section had fractures as shown in Fig. 6. The fractures were determined averagely 1/5 of the way down from the tip, and the rest of the blades had partial damage such as rubbing, and leading & trailing edge nicks. Therefore it was determined that the problem originated from the 8th stage compressor disc dovetail post region fracture. The tow removed compressor blades and debris particles had damaged the 8th exit EGV segments, 1st and 2nd stage turbine nozzle besides 1st and 2nd stage hot section turbine blades.

Fig. 6. 8th Stage Blade Damages on the Compressor Rotor Module.

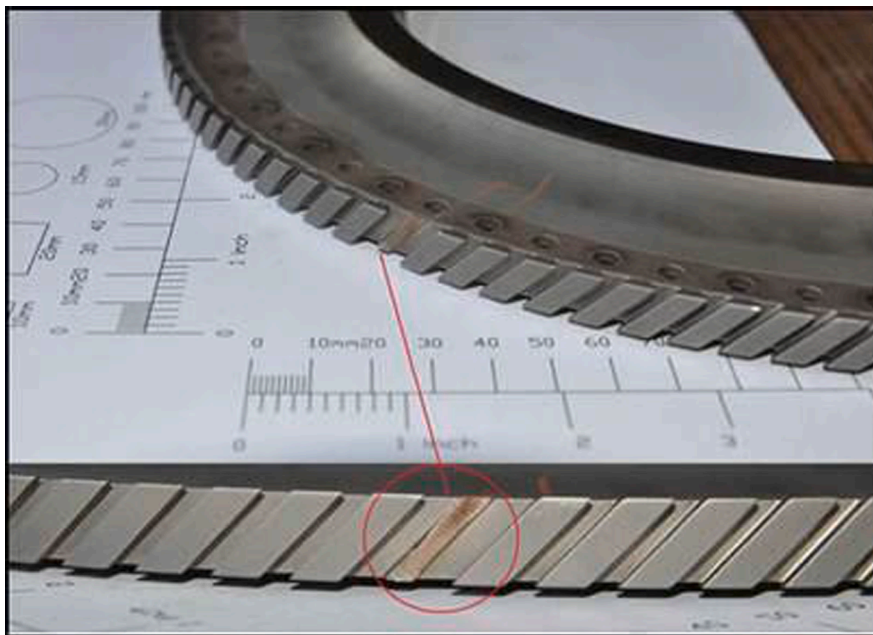
It was observed that one of the dovetail post regions that operate under high tension was damaged fatally. The fractured surface is perpendicular to the disc vertical axis. It was also observed that there was no particular macro plastic deformation and fracture section surfaces were generally clean as it is shown in Fig. 7.

Fig. 7. The Disc Fractured Surface Section.

- Due to high cycle fatigue under repeated loads, the crack propagates to a larger region
- ($\sim 95\%$) of the dovetail post surface.
- Disc dovetail post region is completely broken under overload as a result of not being able to carry loads over the remaining limited section ($\sim 5\%$).
- The crack, which was found at the intersection of the disc dovetail bottom radius and the frontal surfaces where the tension rises, was initiated from the corner part close to the pressure surface of the blade.
- It was concluded that the burr defect originating from the manufacturing process in the region where the crack occurred caused unstable changes in the hardness values of the material and facilitated the crack initiation with the additional notch effect.

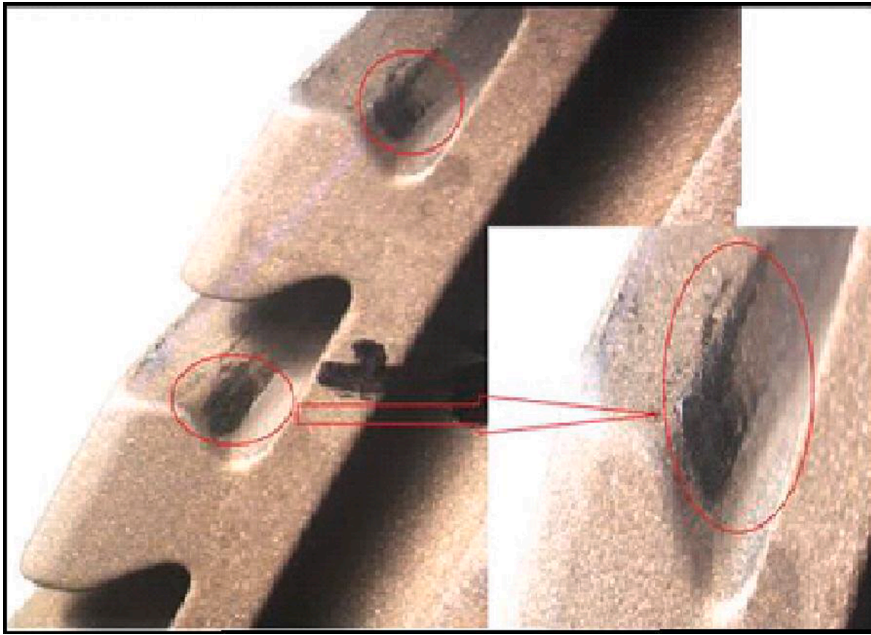
The fractured dovetail post area of the 8th compressor disc, shown in Fig. 8 was observed through a stereo microscope. A fretted surface was determined on the regions that are close to the fracture line and in the post where dovetail and blades are in contact.

Fig. 8. The Fretting in the 8th Stage Disc Dovetail Post.

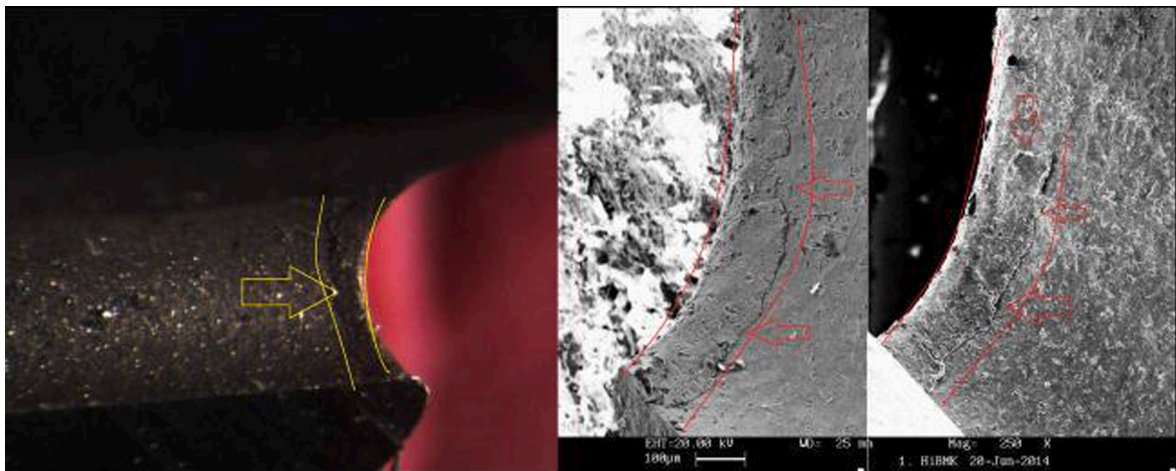
Through SEM, some burrs have been observed on both fractured dovetail posts and the other posts as seen in Fig. 9, some other similar burrs have been seen on the front corner of the disc. These burrs were evaluated as they might be nucleated from machining processes such as broaching or chamfering.

Therefore, it is considered that the fatigue initiation process is nucleated from the burrs due to manufacturing defects and it is observed that the crack propagation had resulted in the ultimate failure.

Fig. 9. The Burrs In The Entrance Section of the Dovetail Post.

- (2) As a result of the instability and notch effect in the material hardness values caused by the burrs on the dovetail post bottom radius part due to manufacturing defects, a fracture occurred on the dovetail post of the 8th stage compressor disc.

- (4) To prevent similar disruptions, all J85-CAN-15 engine compressor discs have been controlled for mechanical damages and imperfections.
- (5) The manufacturer company was informed via technical coordination groups.

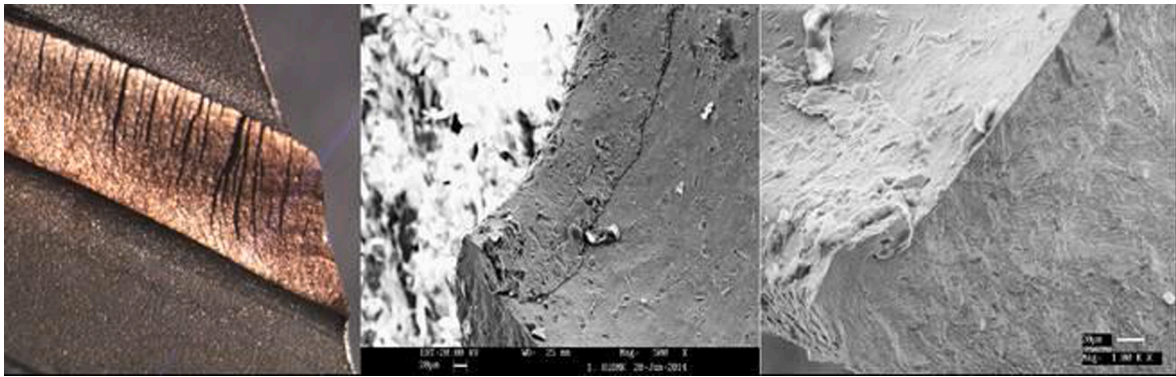
During SEM investigations, some dimples were found as it is shown in Fig. 10. The considerations for the dimples are given below;

- The starting point of these dimples is at the edge fillets and stressed regions where contain burrs which are thought to be originated from manufacturing defects.
- The dimples are located on the front outer part of the blade that close to the pressure surface on the disc and next to the corner cracks that are propagated in semi-elliptical form due to repeated loads.
- In the remaining limited regions, the dimples are formed as a result of ductile fracture with the effect of load.

Fig. 10. Semi-Elliptical Corner Cracks and Pits Formed in the Fracture Section.

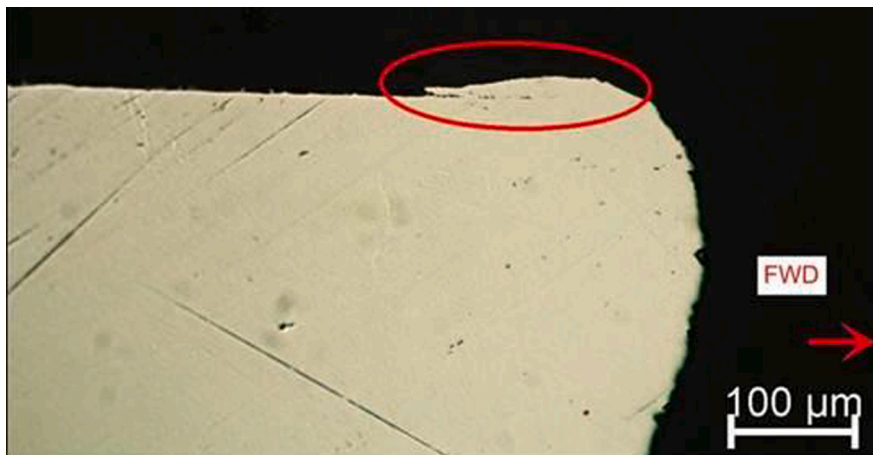
- As it is shown in Fig. 11, the dimensions of the burrs are $\sim 170 \mu\text{m}$ in the axial direction and thickness is $\sim 18 \mu\text{m}$ in the radial direction.
- No significant conversion was found other than the variation of fibrous direction that was originated from the burrs due to manufacturing defect.

Fig. 11. Fibrous Dimensions Caused by the Burr due Manufacturing Defect.
