Original Solutions for Structural and Functional Rehabilitation of Masonry Buildings

Abstract- The paper presents strengthening solutions and elements of functional rehabilitation for a certain class of 2-4 storied historical buildings of masonry structure. In order to protect the ornamental plastering of the ceiling, an original technology of rehabilitation for large spanned timber slab structures was performed. The worked out technical solution was applied on several buildings. It is presented on the case of a historical building from the 19th century. This case also gives the opportunity to emphasizing the functional improvement of the building.

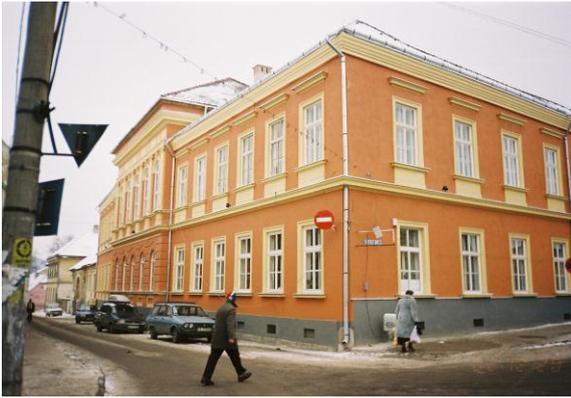
Fig. 1. Palace of Justice in Odorheiu-Secuiesc

The palace initially housed not only the trials, but also the prison. Consequently, the organization of the interior spaces corresponded to the functional requirements of that time. It is a two-storied building with basement (Figure 1).

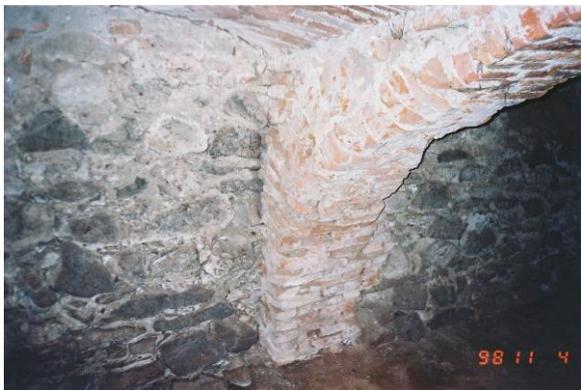
Fig. 3. Masonry stone walls, brick arch and vault

The structure of the cellar is of masonry stone walls sustaining brick arches and vaults (Figure 3).

The masonry vault system of the basement is supported by masonry arches and walls (Figure 3). It is to be mentioned the pronounced flatness of the brick arches.

The examination of the masonry vaults and arches put into evidence two main aspects: cracks and breaks with detached bricks on the one hand and important vertical displacements on the other hand. Obviously, the vault system had to be discharged [17], [18]. For this purpose, a new independent slab system was performed over the initial bearing system (Figure 4). It consists in a reinforced concrete slab on metal beams leaning on the stone walls. So, the vaults and arches have to carry only their own weight. The detached and destroyed pieces of brick were replaced with new ones and the masonry joints were filled with lime mortar with powdered brick as hydraulic additive.

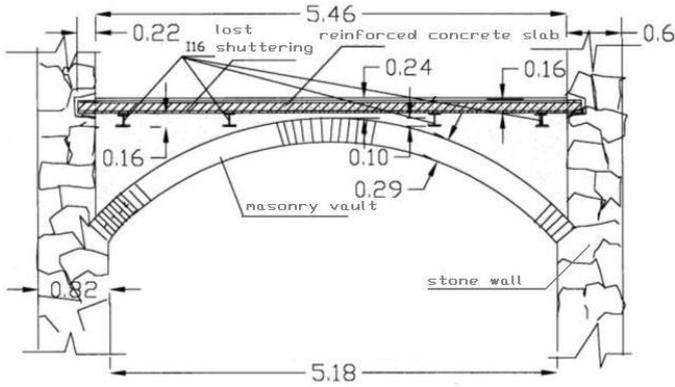
Fig. 4. Consolidation of the slab system over the basement

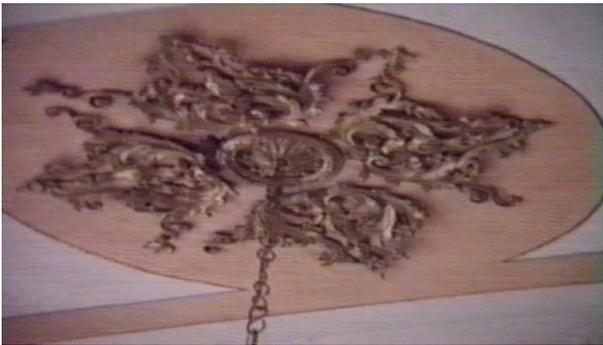
Fig. 5. Plastering in stucco of the ceiling

The most inconvenient phenomenon was the great deflection of the slab, respectively of the main beams. The measured vertical displacements at the middle of the beams were between 11 and 14 cm. This phenomenon caused serious damages, i. e. visible cracks in the ornamental stucco plastering of the ceiling (Figure 5).

The aim was to find a technique of intervention to diminish the deflections saving the ornamental plastering of the ceiling too. For this purpose it was necessary to bring the timber slab back near to its initial form [20], [21]. In this respect, at first, the slab has been discharged taking away the vertical loading given by the floor (thermal insulation and bricks). Secondly, the middle of the main beams had to be lifted for diminishing the vertical deflections. The solution was to build over each main timber beam an independent reinforced concrete girder (Figure 6) supported by the marginal walls.

In this way the middle of the main beams could be lifted with 8 – 9 cm without displacements of the supports. This rising of the axes of the beams was enough to close the cracks of the ornamental plastering and finally permitted a proper restoration of the ceiling.

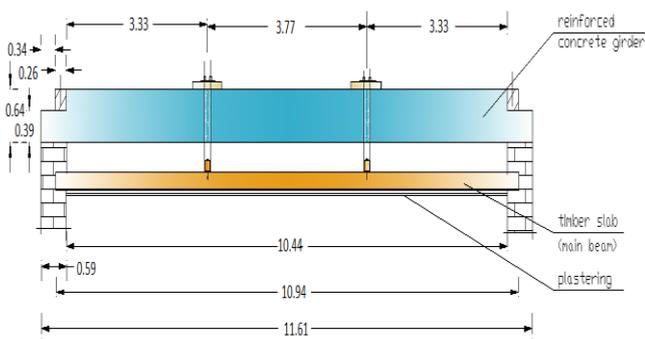
Fig. 6. Lifting girder

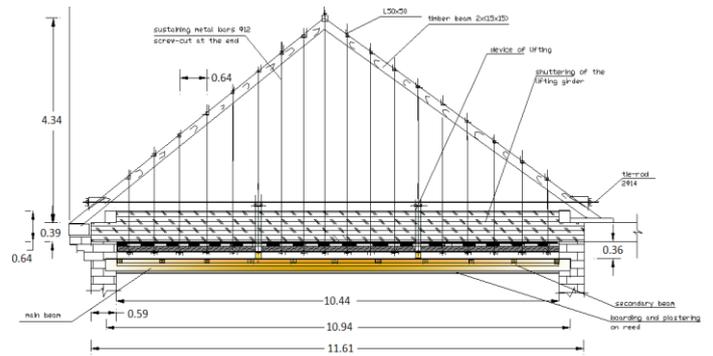
An additional temporary sustaining system was conceived to sustain the shuttering, the reinforcement and the cast concrete of the lifting girder. It consists in a triangular timber structure with a tie-rod (Figure 7 and Figure 8) to which the vertical loading is transferred by a series of vertical metal bars.

Fig. 7. Additional supporting structure of the lifting girder-design

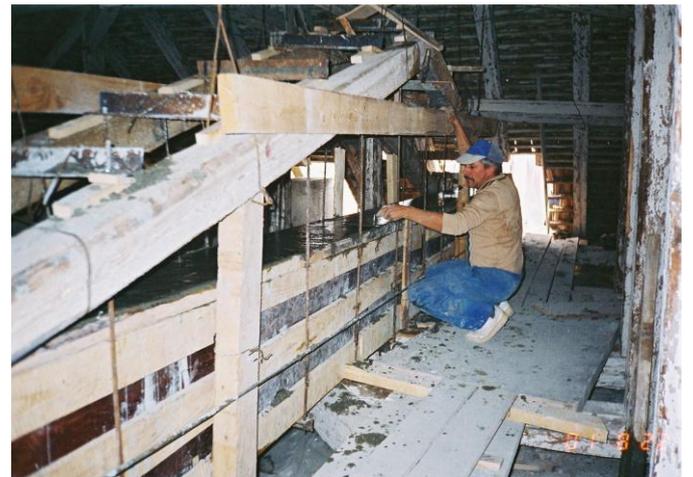
Fig. 8. Additional supporting structure of the lifting girder- photo

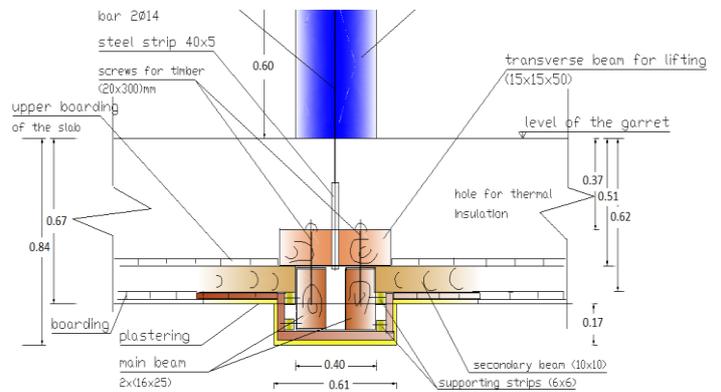
A transverse section of the whole lifting system, after striking the reinforced concrete girder, is presented in Figure 9.

Fig. 9. Transverse section of the lifting system

The operation of lifting can be performed in two ways:

(a) Lifting the slab before casting the girder, using the additional timber structure for lifting; in this way the bottoming of the two lifting bars is made automatically by the concrete hardening; a relatively short time for the operation can be assured (7-8 days);

(b) Lifting after the execution of the reinforced concrete girder; the lifting bars pass through the girder by former embedded tubes; it has the advantage of a perfectly controlled way of lifting and bottoming the lifting bars on the girder surface by screwed devices; the time of operation is relatively long because of the hardening time of the concrete;

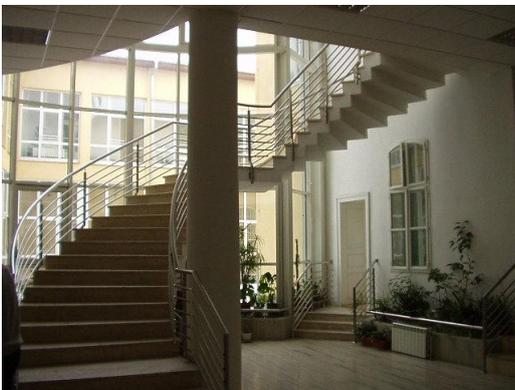
For improving the circulation flux in the building and also responding to the actual requirements concerning emergency evacuation, a new staircase was added to the old building [22], [23]. The originality of the solution consists in the fact that the architect didn't try to take again the initial style of the building [24], [25]. On contrary, aiming to a maximum functional and structural efficiency, a very modern solution in reinforced concrete and glass was adopted (Figure 10, Figure 11).

Fig. 10. New staircase - interior view

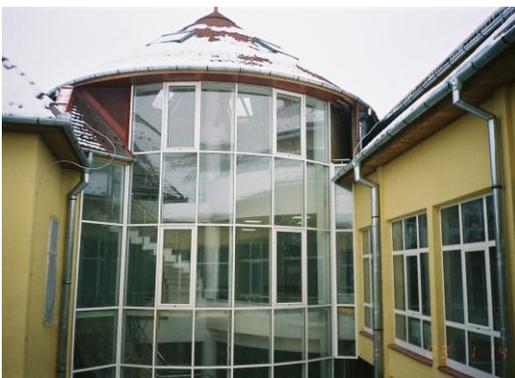
Fig. 11. New staircase - exterior view
