Assist. Prof. Dr. Tamer Saraçayakupoğlu
Mechanical Engineer

Fatigue Studies in Aviation in Light of the 1988 Aloha Airlines Incident

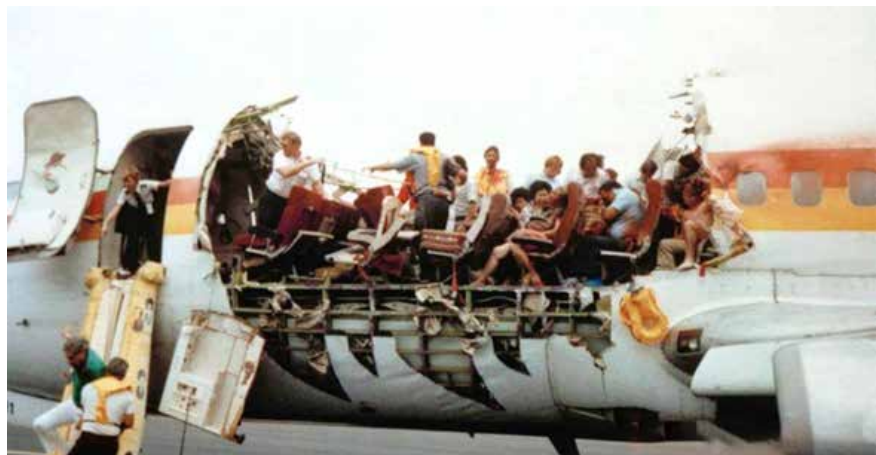
Figure 1. The 1988 Aloha Airlines Incident Occurred due to Lap-Joint of Fuselage Fatigue Failure

history that occurred due to structural failure which resulted from aircraft fatigue damage. For example, the incident with flight 243 that occurred on April 28, 1988 with a Boeing 737-200 type aircraft, that took off from the city of Hilo, Hawaiian Islands, to the city of Honolulu. While the aircraft was climbing to cruising altitude, an explosive decompression was experienced. According to the National Transportation Safety Board (NTSB) report, approximately 18 feet of the cabin skin, structure aft of the cabin entrance door, and above the passenger floor-line separated from the aircraft as shown in

Due to the sudden pressure change caused by the explosive decompression, one flight attendant was swept overboard, and 7 passengers and 1 flight attendant suffered serious injuries. The crack originated by fatigue failure on the fuselage lap joints was the core reason for the accident (NTSB, 1988). It is important to mention here that controlling the structurally decomposed and fragmented aircraft could have only been achieved by highly skilled heroic pilots. The passengers were lucky because heroic and highly skilled pilots were in the cockpit that day. Otherwise, the scenario could have been much worse because 89

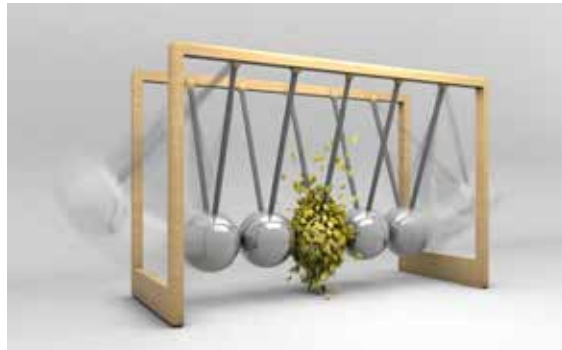
Figure 2. Fatigue Failure Under Repetitive Forces Demonstrated with Newton's Cradle

In time, studies on fatigue failure have shown that there is a natural correlation between fatigue and vibration. While classic significant theorems imply implicitly that material under cyclic loading behaves stable after only one or two loading cycles, the experimental investigations show that stable cycles can be reached only after several loading cycles and sometimes only asymptotically. Eventually, fatigue failure is the result of the progressive and localized structural damage that occurs when a material is subjected to repetitive or fluctuating cyclic loading as it is depicted as Newton's

Cradle in **Figure 2**.

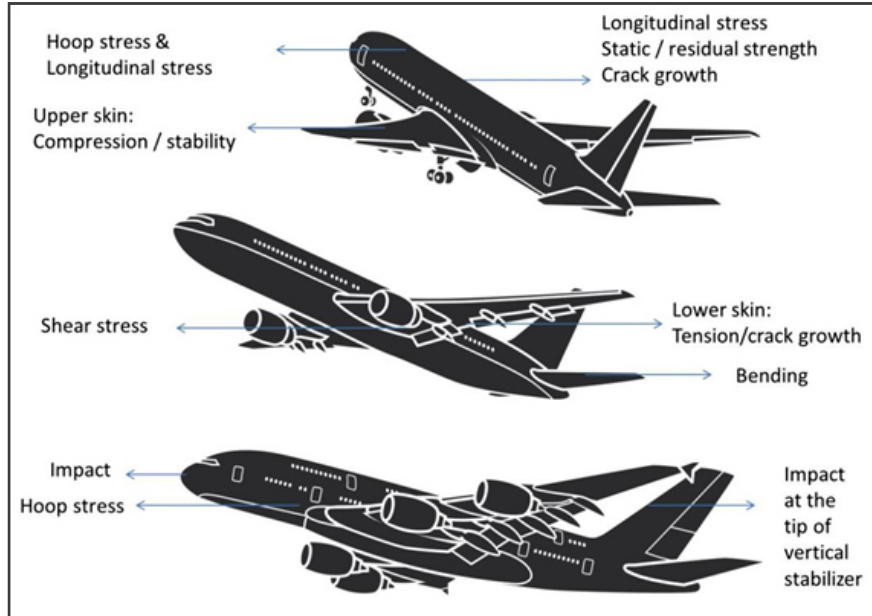
Figure 3. Stress Forces of an Aircraft (Wanhill, 2014)

To illustrate this concept in a simplified case, the obtained force can be determined using Newton's formula ($F = ma$) by summing all the accelerations imparted to the air. Dependently, every object in the aircraft experiences a force equal to the object's weight times the aircraft load factor. This situation creates additional stresses throughout the aircraft, which must be determined. It is noteworthy that, the weight of the wing structure will produce torsional loads on the wing in addition to the aerodynamic torsional loads. Besides four basic forces (Lift, weight, thrust, drag) the stress forces and loadings acting on the aircraft are depicted in **Figure 3**.

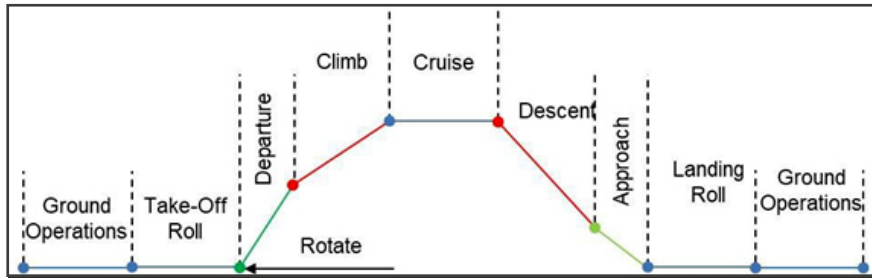
Figure 4. The Phases of a Flight (Dorfing, 2007)

So far it has been stated that repeated loads and random vibrations may likely be the core of fracture failure. It should also be underlined that vibrations vary in accordance with different flight phases as mentioned above. In order to illustrate flight stages, we can review a plain flight profile which can be divided into some stages such as ground operations before take-off, take-off roll, departure, climb, cruise, descent, approach, landing roll, ground operations after landing as it is shown in **Figure 4**.

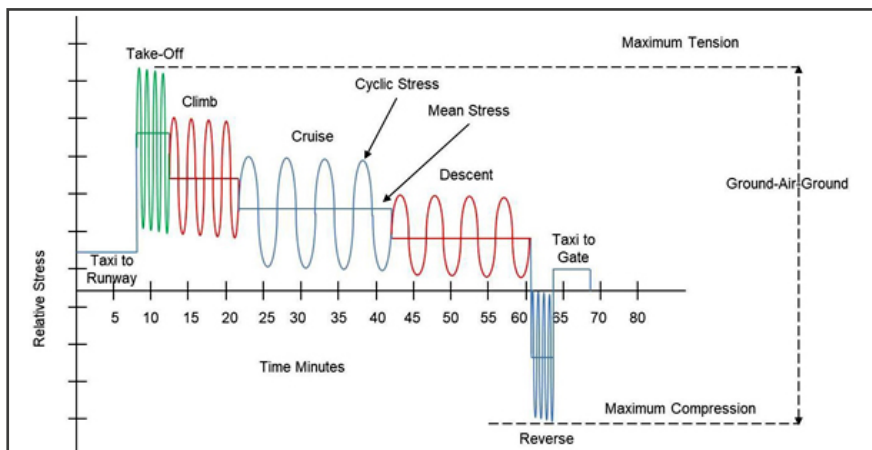
Figure 5. Representation of the Vibratory Stress Cycles for Each Flight Stage (Adapted from FAA) (FAA, 2001)

Every flight stage has its own characteristics and also has its own unique stresses load as it is demonstrated in **Figure 5**.

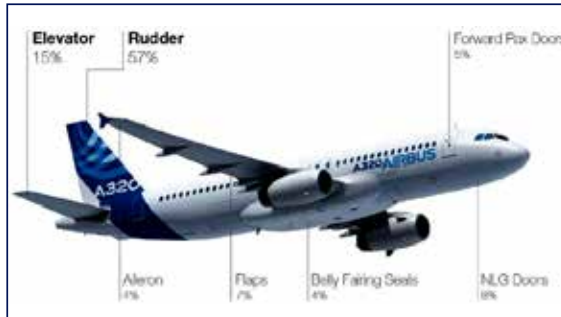
Figure 6. The Main Sources of Vibration on the A320 Family Aircraft (Airbus, 2017).

primarily indicates that the vibration is coming from the ailerons. In **Figure 6**, the vibration percentage

of moveable control surfaces is shown on the Airbus A-320. In general, the moveable parts are attached to the fuselage with hinges. In general, the aircraft manufacturers also create checklists such as the Vibration Reporting Sheet (VRS) (Airbus, 2017).

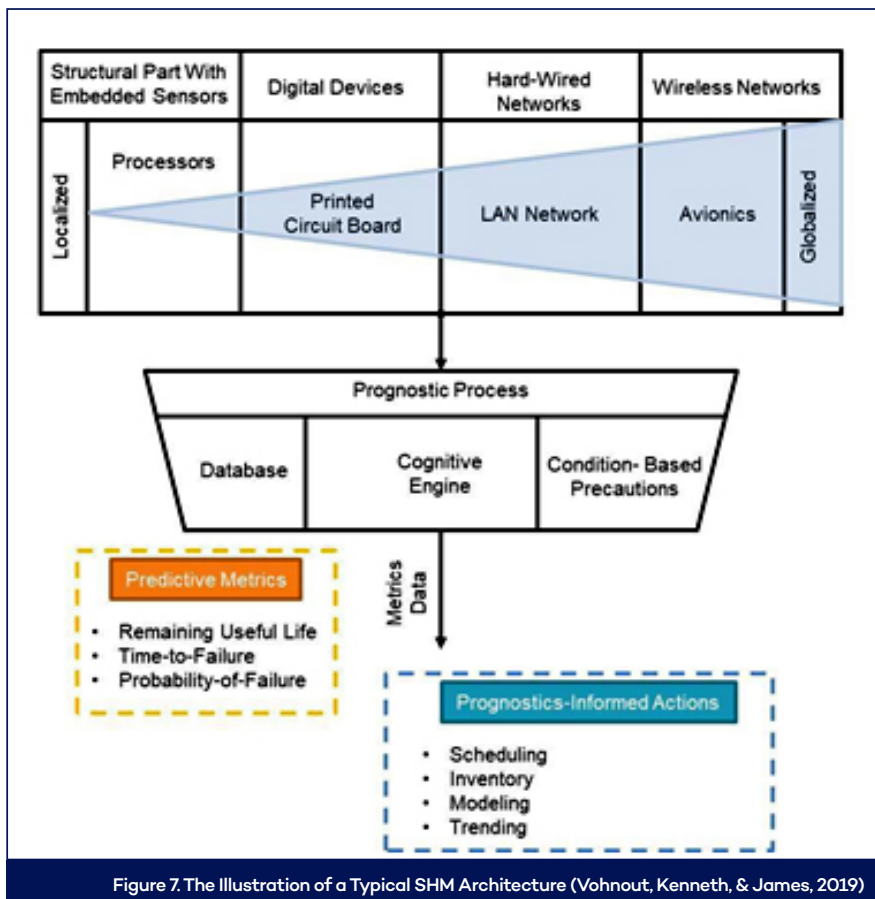
Figure 7. The Illustration of a Typical SHM Architecture (Vohnout, Kenneth, & James, 2019)

Figure 7 illustrates the steps from the fatigue-

failure sensor-embedded structural part to the end-evaluator of a trend monitoring the system architecture

For sure, in the future with the help of additively manufactured smart structural parts, the fatigue failure data will be transferred from their in-situ origins. As shown in Figure 7, this data will be used proactively to ensure aviation safety. The information will be evaluated in real-time for the determination of remaining life, time-to-failure, and probability of failure as well 🔄
