# Construction and Building Materials

## Mechanical and durability performance of FRP confined and unconfined strain hardening cementitious composites exposed to sulfate attack

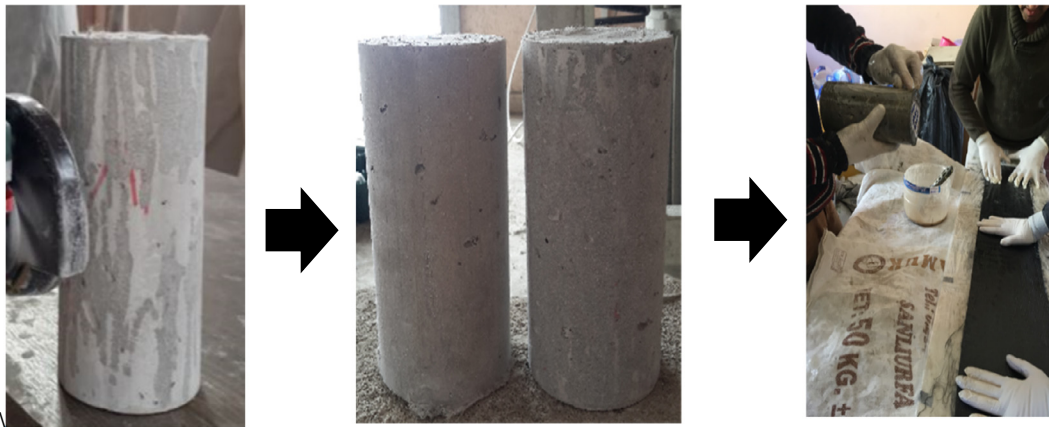
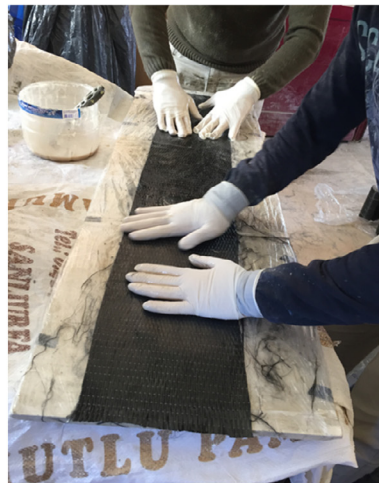
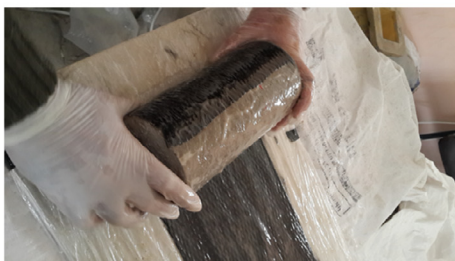
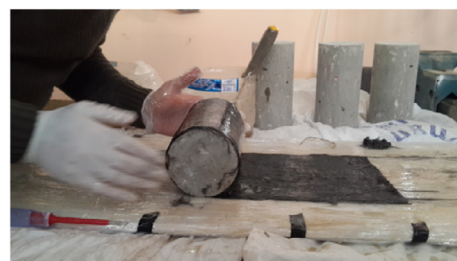
**Fig. 1.** Steps of applying FRP fabric.

In the first step of the FRP application procedure, the surface of the specimen was prepared by removing the residual powders using a wire brush and cleaning the surface from remaining powders using an air compressor. In the second step, the sheet of FRP fabrics were prepared by cutting the sheet with a length of 115 cm (three-layer continuous wrapping length with an overlaps of 15 cm between layers) and width of 19 cm (left 0.5 cm at both top and bottom side of cylinder specimen to avoid axial load on FRP sheet). In the final step, application of FRP fabrics was attained by saturation inner sides of the FRP fabrics with epoxy resin and specimens were placed inside of the FRP fabrics, then three layers wrapping process were achieved with epoxy resin. In the FRP application process, to eliminate and fill the pores on the surface of the specimen and to get the excellent bond between concrete and FRP fabrics, the surface of the specimens was also coated with epoxy resin. In addition, the orientation of fibers inside FRP sheet was taken into consideration during the wrapping procedure to certify the orientation of fibers perpendicular to the axial direction

of loading. To get the perfect bond between FRP layers and to avoid slippage of the FRP layers, an overlap length of 15 cm was provided for the outermost layers of FRP sheet. During the wrapping process, separation of fibers from the edge of FRP sheets was avoided to prevent early failure of the specimens. After FRP wrapping process, specimens were left at room temperature for 7 days to achieve the targeted strength of the epoxy resins. After the three-layer of wrapping period, the thicknesses of the FRP sheets was determined using caliper as 0.9 mm outside from the overlap region.

a) Concrete surface preparation

b) FRP sheets preparation

c) Application of FRP fabric

Cylinder specimens with dimensions of 100 mm and 200 mm in diameter and length respectively were cast to evaluate the compressive strength of SHCC specimens. After 24 h, specimens were demolded and cured in water at 23 ± 2 °C for 28 days. Then specimens were left in an ambient condition for drying. After required strength, three layers of carbon and basalt fiber reinforced polymer (FRP) wrappings were realized on certain specimens according to the FRP application procedure as shown in Fig. 1.

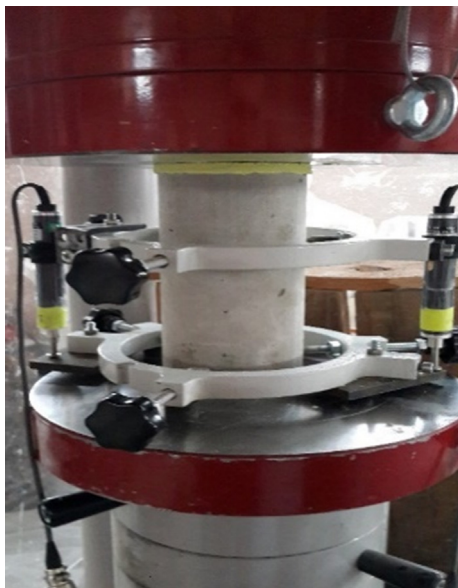
Fig. 2. SHCC specimen under axial load.

Compressive strength tests were carried out on confined and unconfined cylinder specimens under static and cyclic loadings. Compressive strength tests were carried out according to ASTM C39 [29]. All compressive strength tests were performed under displacement controlled loading with a rate of 0.2 mm/min. Two linear variable displacement transducers (LVDT) were attached to measure axial deformations in the specimens as shown in Fig. 2. Stress and strain data were obtained for each specimen.

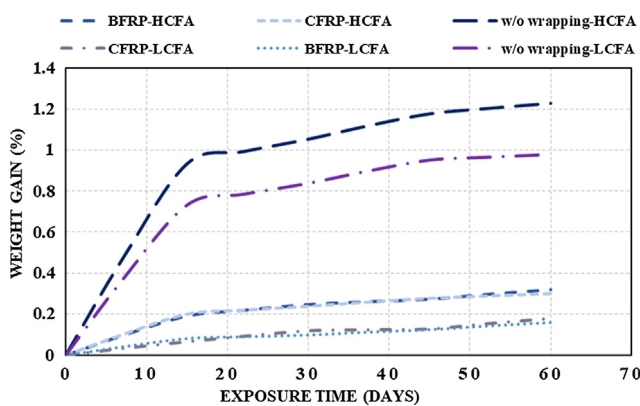
Fig. 4. Weight gain in SHCC specimens exposed to sulfate attack.

Fig. 4 indicates weight gain (%) of the specimens under two months of chemical exposure. Results presented that all specimens had weight gain under sulfate solution absorption, and unconfined specimens showed the highest weight gain. The gained weights were 0.98% for LCFA specimens and 1.22% for high calcium fly ash HCFA specimens. Confined HCFA also showed slightly higher weight gain than the confined LCFA specimens. Moreover, the lower weight gain showed in LCFA specimens confined by carbon FRP (CFRP) and therefore, the specimens confined by CFRP fabrics showed slightly better chemical resistance than BFRP fabrics under sulfate attack. Lower weight gains showed in confined and unconfined LCFA specimens may be due to the higher fineness ratio, which caused a reduction in porosity and reduced chemical solution absorption. The earlier research was also reported the weight gain due to chemical exposure [32,33]. The penetration of harmful actions from chemical solution reacted with cement and caused the formation of gypsum and ettringite. As a result, increased volume by a factor of about two and reduced density of concrete [34]. Therefore, initial weight gains of the specimens exposed to the chemical solution may be due to the increase in relative volume was more than the reduction amount in relative density [31].

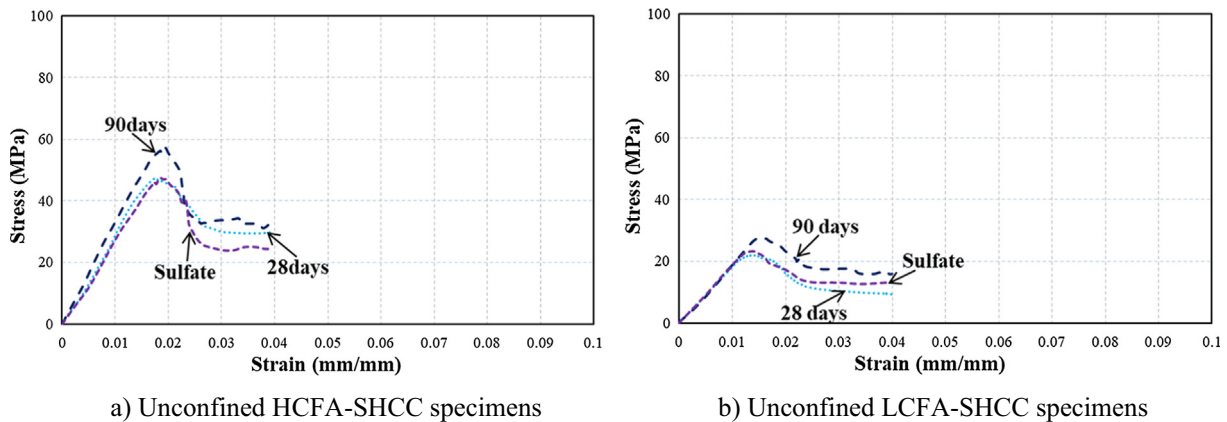
**Fig. 5.** Stress–strain curves of unconfined SHCC specimens.

Fig. 5 indicates typical compressive stress–strain curves of unconfined SHCC specimens. Results showed that compressive strength of unconfined specimens increased up to 90 days. The continuity of hydration reactions and the slow pozzolanic reaction of fly ash may be the reason for the increase in the compressive strength. Similar outcomes were also stated in the previous investigations [2,35].

The compressive strength values of 90-day curing specimens were 27.72% and 19.94% higher than the compressive strength values of 28-day curing for LCFA and HCFA specimens, respectively. Higher improve in the compressive strengths of LCFA specimens at 90-days ages compared to HCFA specimens was expected because of lower CaO amount in the low lime-fly ash (LCFA) specimens since the rate of hydration reactions was slow, where strength improvement (C<sub>3</sub>S and C<sub>2</sub>S creation) became time dependent. Reductions in compressive strength for the specimens exposed to sulfate attack were 0.17% and 14.92% for 28 days, 10% and 16.48% for 90 days strengths of LCFA and HCFA specimens, respectively. Higher reduction in compressive strength for HCFA specimens may be also attributed to high CaO content in the in the high lime-fly ash (HCFA) specimens.

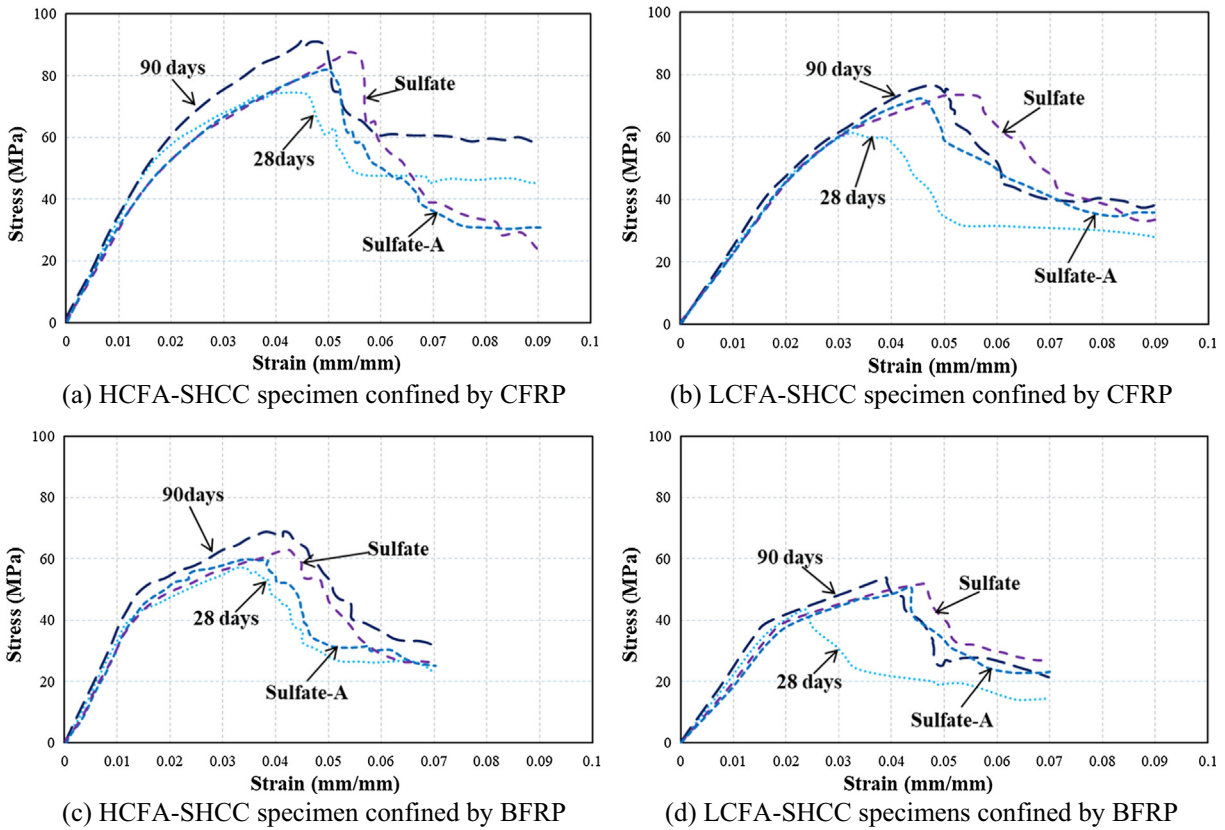
Fig. 6. Stress-strain curves of confined SHCC specimen.

Fig. 6 represents the compressive performance of confined SHCC specimens. Results showed a significant increase in compressive strength for SHCC confined by FRP fabrics (more than 2–3 times) when compared to unconfined specimens. In general, the compressive load decreased suddenly as the outermost layer of FRP fabrics ruptured and then the load started to increase or continue at a constant value due to stress move from FRP fabrics to SHCC concrete until the failure of the inner layer of FRP fibers and PVA fibers inside the SHCC specimens [36].

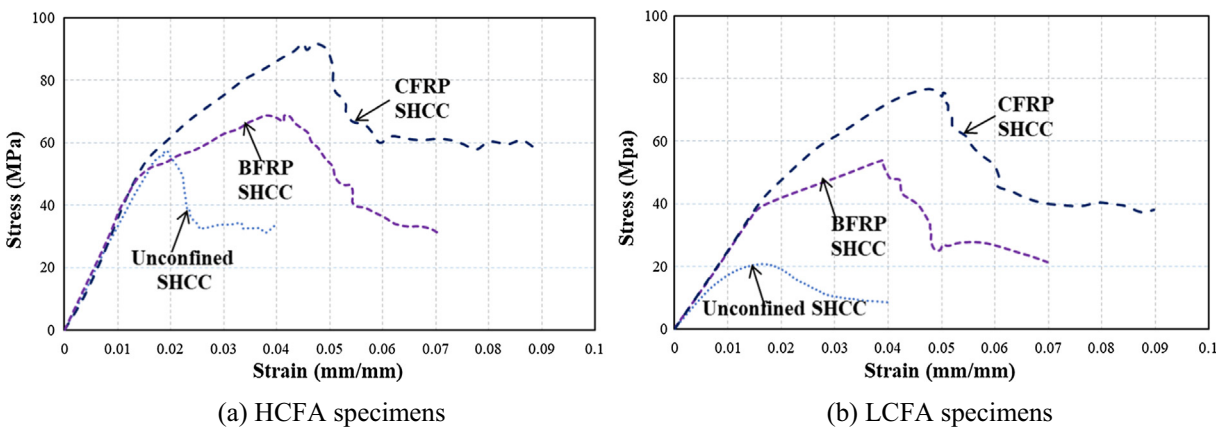
Fig. 7. Stress-Strain Curves of confined and unconfined SHCC specimen.

including PVA fibers continued to resist the axial load until failure of PVA fibers. Carbon FRP fabrics confined specimens exhibits superior strength and ductility amount than the basalt FRP fabrics confined specimens and the poor behavior was achieved in the unconfined specimens as indicated in Fig. 7.

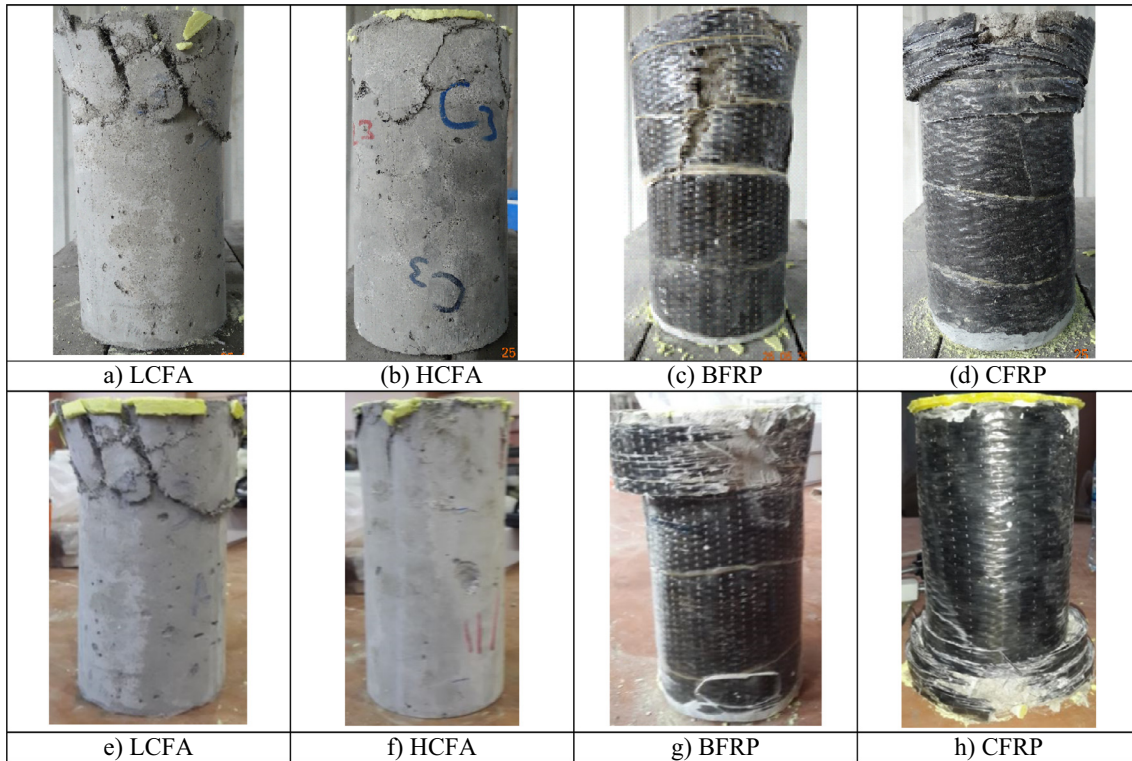
Fig. 8. Failure mode of SHCC specimens exposed to sulfate (a, b, c, d) and control (e, f, g, and h).

In Fig. 8a and e, the failure modes of LCFA specimens were found almost the same under sulfate and control environments, which indicated that LCFA specimens does not much affect the failure mode. Concerning the HCFA specimens, the effect of sulfate solution led to a relatively negative effect (more deterioration) on the failure as can be seen in Fig. 8b and f. This could be

explained by the existence of high calcium content in HCFA specimens. When confining the specimens with basalt FRP fabrics, more deterioration was observed under sulfate solution than control environment as can be seen in Fig. 8c and g. This can be explained by the fact that basalt FRP fabric can react with the sulfate solution, leading to a weak performance against sulfate solution. On the other hand, carbon FRP fabrics showed the same failure mode under sulfate and control environments as can be seen in Fig. 8d and h. Due to the high tensile strength capacity, failure was observed at top regions of the specimens, which can be attributed to the friction between machine plates and specimens.
