# OPEN GIS-based monitoring of urban utility excavations for permit compliance and pavement management in smart cities

**Keywords** GIS-based real-time monitoring, Remote inspection, Pavement management, Pavement reinstatement, Geofencing, Infrastructure resilience

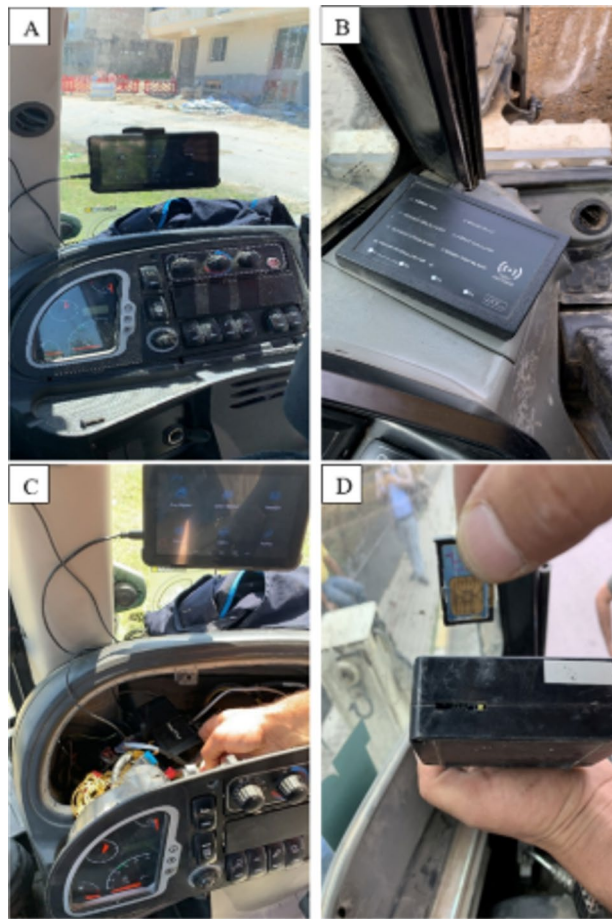
**Fig. 4.** Onboard hardware configuration of the excavation tracking unit (a) in-cab operator display, (b) RFID-based authorization reader, (c) onboard control unit, (d) cellular communication module.

The onboard hardware installed in the excavator cabin functions as the central data acquisition, processing, authorization, and communication unit. The onboard control unit receives signals from the excavation activity sensors and combines these data with GNSS-based location information. The unit also includes communication interfaces, a SIM card module for cellular data transfer, camera interfaces for visual verification, auxiliary input/output ports, and a GNSS/GPS antenna connection. A dedicated operator display provides real-time feedback regarding the current system status and alarm condition. In addition, an RFID-based authorization unit is used to verify the operator or operation before excavation begins. Under the proposed workflow, excavation can proceed only when the operator or operation is recognized within the designated work zone and verified by the responsible authority (Fig. 4).

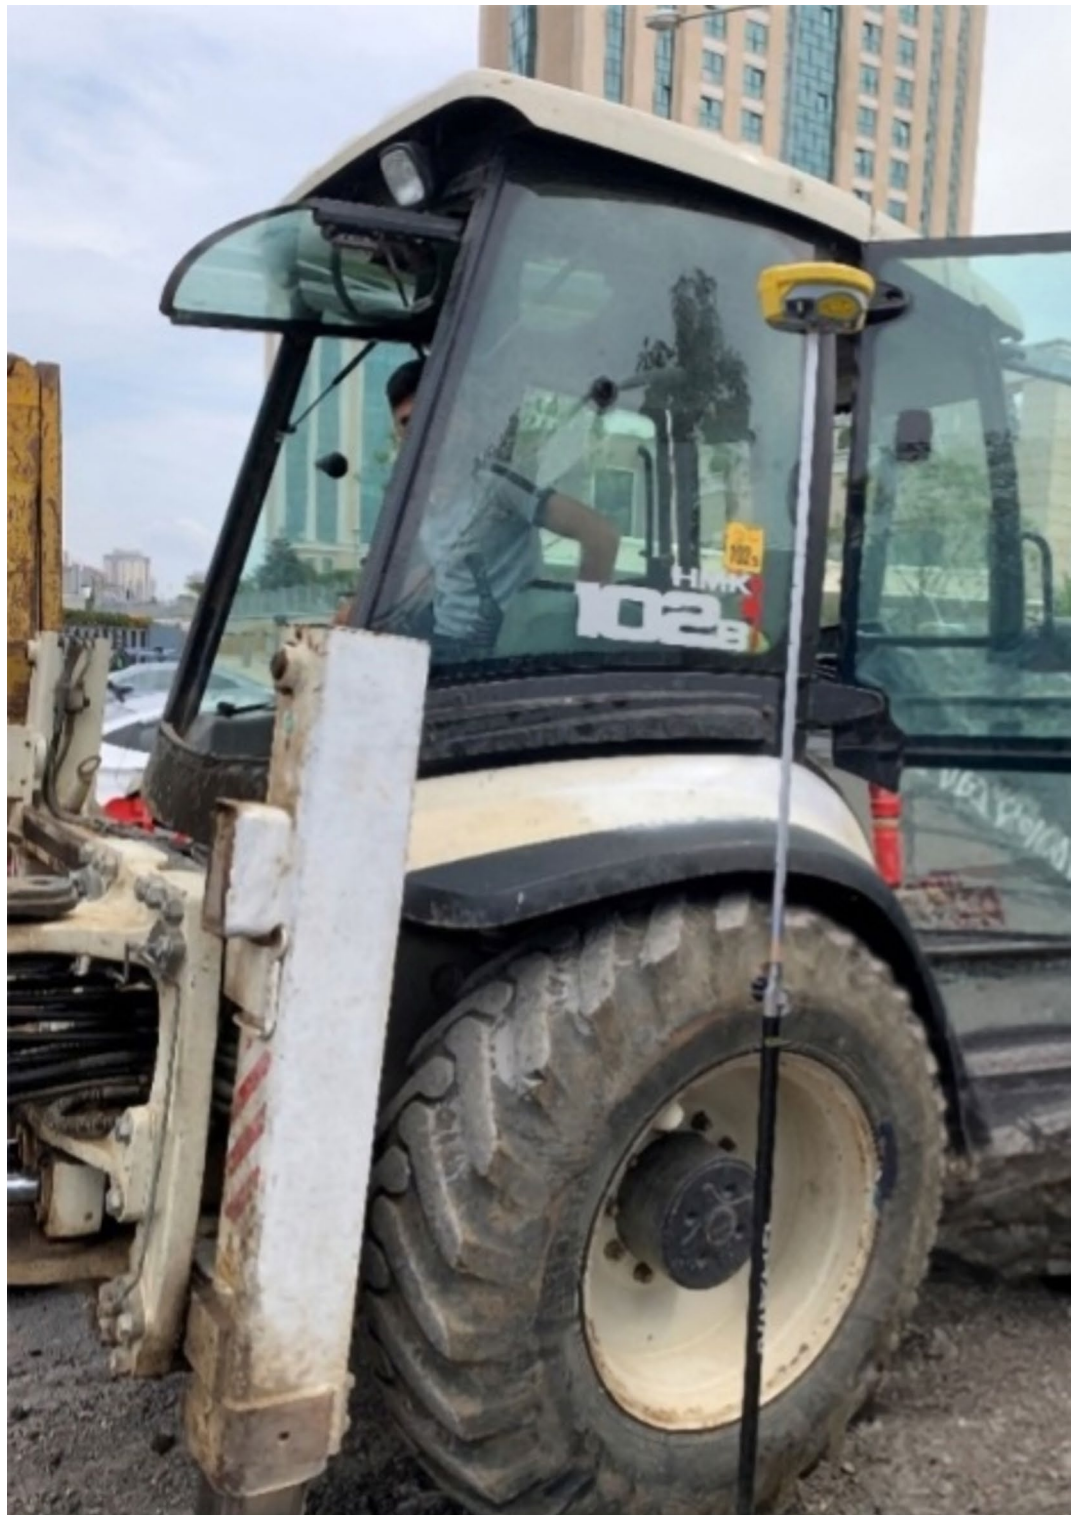
**Fig. 6.** Field validation procedure used to compare GIS-PIMS tracking outputs with survey-grade RTK-fixed GNSS reference measurements.

The commercial vehicle tracking device antenna was rigidly mounted on the top exterior of the excavator cabin structure to maximize sky visibility. For ground-truth validation, the survey-grade GeoMax Zenith 25 Pro RTK-GNSS antenna was positioned on a survey range pole aligned with the vertical axis of the tracking unit antenna. The RTK-GNSS receiver received real-time kinematic differential corrections from the ISKI-CORS (NRTK) network via cellular connection. Measurement points were selected based on operational safety, active excavation state, and spatial proximity to underground infrastructure lines. Positioning coordinates were

logged only after achieving a verified RTK-Fixed ambiguity solution with an internal horizontal accuracy status threshold of  $< 15$  mm.
