# Performance assessment of irregular RC buildings with shear walls after Earthquake

This paper discusses the behavior of frame-wall irregularity on established existing reinforced concrete (RC) structures that were subjected to the 1999 Kocaeli Earthquake in Turkey. In particular, reference is made to the nonlinear static analysis and nonlinear dynamic analysis of reinforced concrete (RC) structures containing shear walls. The layered shell model has been chosen due to its advantages. The damage observed after reconnaissance studies has been captured using the 3D model. The imperfections that the irregularity effects caused are discussed throughout the paper.

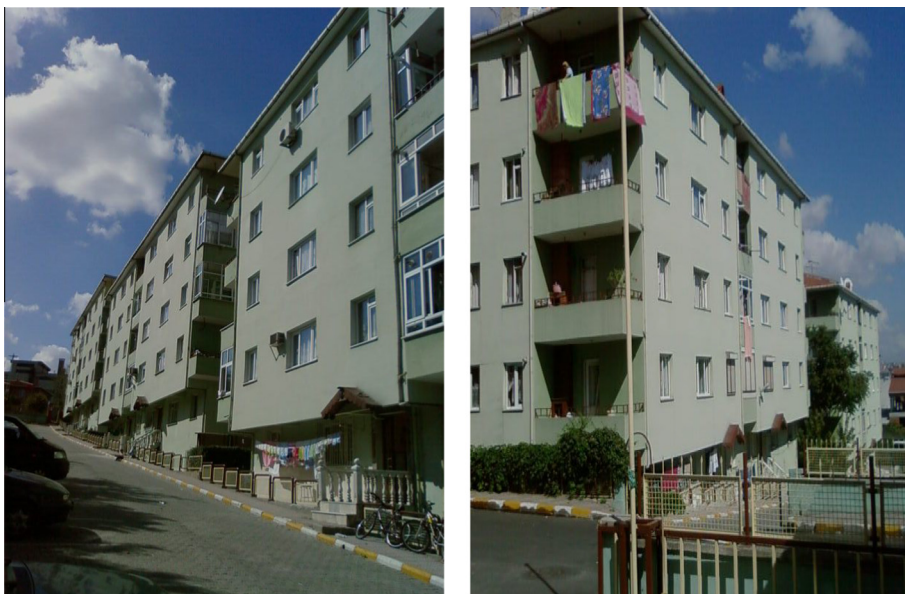
To observe the effect of shear wall irregularities, two RC buildings in Kocaeli, Turkey were considered. The extended N2 method [13–15] proposed by Kreslin and Fajfar was applied on the selected structures. The two RC buildings have the same elevation and structural properties and were built in the same year by the same construction company. The only difference between the buildings is that the bottom story of one of the buildings is edged with a continuous shear wall, whereas the other one is not. In the latter building, there is a supermarket in the bottom story. The outer view of these buildings is given in Fig. 1.

Fig. 1. Observed RC buildings.

The buildings under consideration are 6-storied and the height of each floor is 2.75 m. Concrete bore samples were taken from the buildings and their concrete strength was found to be 10 MPa. From investigations it was found that S220 steel was used as rebar. Six different column sections and one type of beam section were established from the reconnaissance studies. The sizes of the established columns were found to be 25 cm \* 35 cm, 25 cm \* 40 cm, 25 cm \* 50 cm, 25 cm \* 60 cm, 30 cm \* 60 cm and 60 cm \* 25 cm, whereas the dimensions of all the beams were found to be 20 cm \* 60 cm. Soil type was selected as Z2 which corresponds to periods of 0.15 s and 0.40 s (periods of corners of design spectrum proposed by TSC 2007) and since the selected buildings are residential ones, the importance factor and the live load attendance were taken as 1.0 and 0.3 respectively.

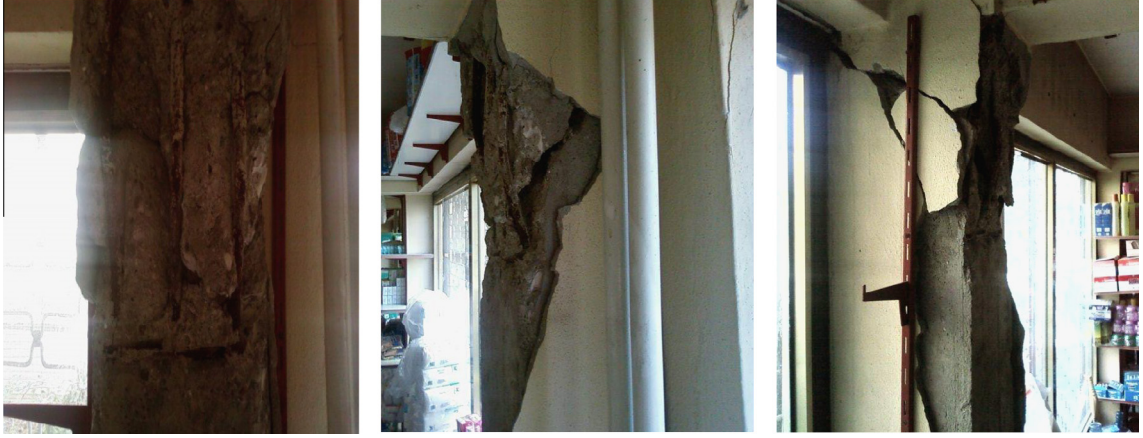
After the 1999 Earthquake hit the province of Kocaeli, the building with the shear wall irregularities at its bottom story had major damage: one of its columns had shear damage and had buckled severely. The other building with the continuous shear wall had no damage, though. Fig. 2 shows the observed shear hinge damage pattern.

Fig. 2. Damage pattern in the column in which shear hinge was observed.

Shear capacity determination for the damaged column of the irregular RC building is shown in Table 7. The design shear force value is found to be approximately 45 kN. As can be seen from the table, the design shear capacity is exceeded for the mentioned column.
