# The aftermath of 2023 Kahramanmaras earthquakes: evaluation of strong motion data, geotechnical, building, and infrastructure issues

## Abstract

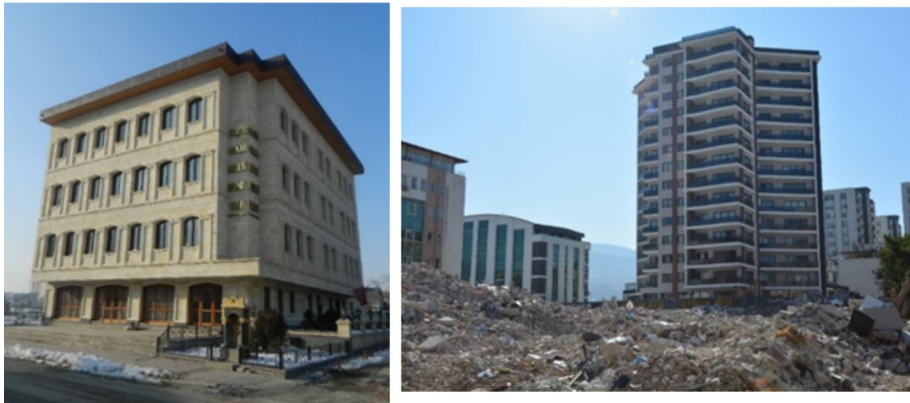
- It has been observed that buildings constructed adjacent to each other with insufficient expansion joints suffered damage because of collisions under strong ground motion. This structural irregularity, observed in adjacent buildings with different floor levels and referred to as the “Pounding Effect,” can cause severe damage, even total collapse, in structures with different dynamic characteristics (Fig. 25).
- Despite the extensive damage, there are also structures in the region that survived the earthquakes without any damage (Fig. 26).

**Fig. 26** Undamaged structures after the earthquake
